# PREDICTIONS OF RELATIVE SEA LEVEL CHANGE AND SHORELINE EROSION OVER THE 21<sup>ST</sup> CENTURY ON TANGIER ISLAND, VIRGINIA

## ABSTRACT

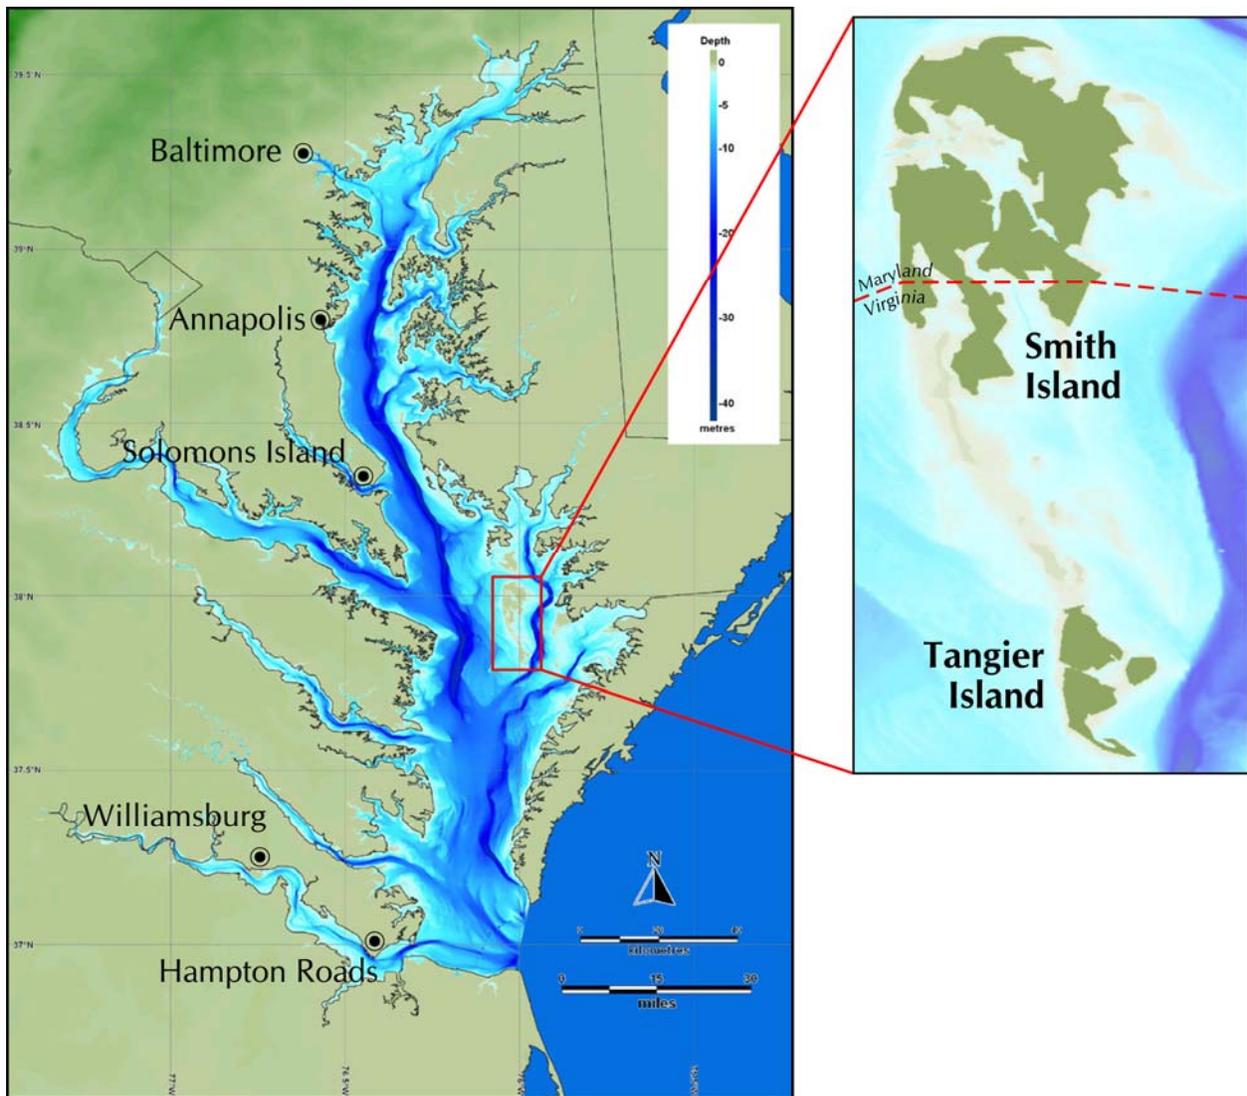
Figure 2. Bathymetric map of Chesapeake Bay showing Tangier Island.

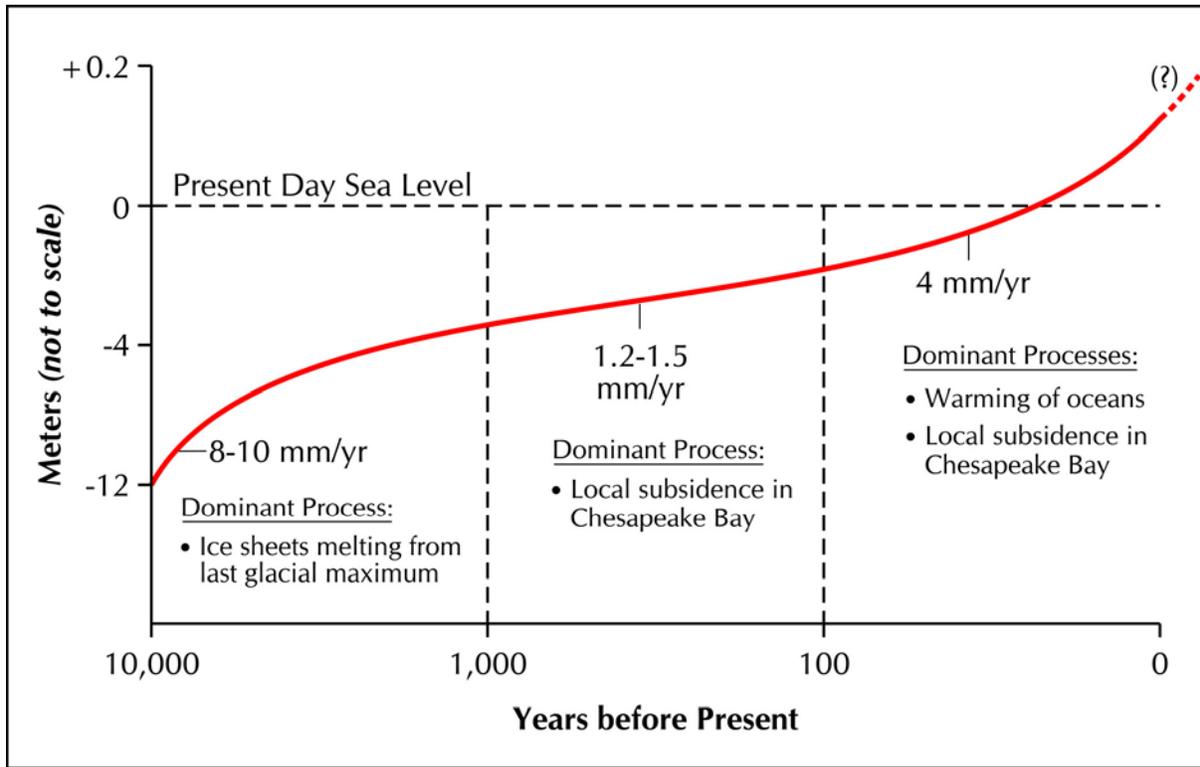
Figure 3. Qualitative relative sea level trend in Chesapeake Bay over the past 10,000 years.

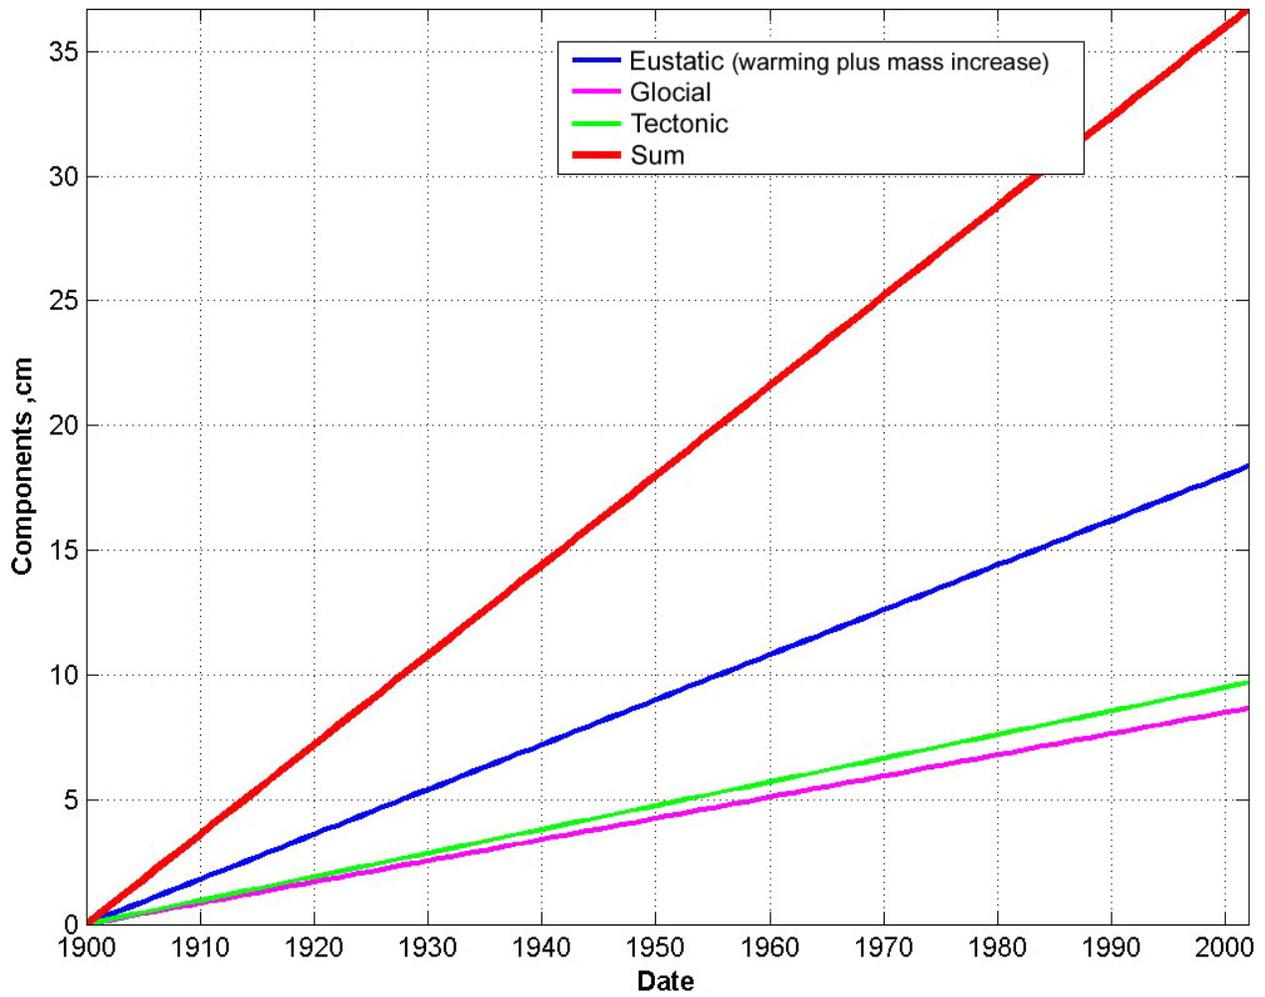
Figure 4. Components of relative sea level rise in the Chesapeake Bay over the past century.

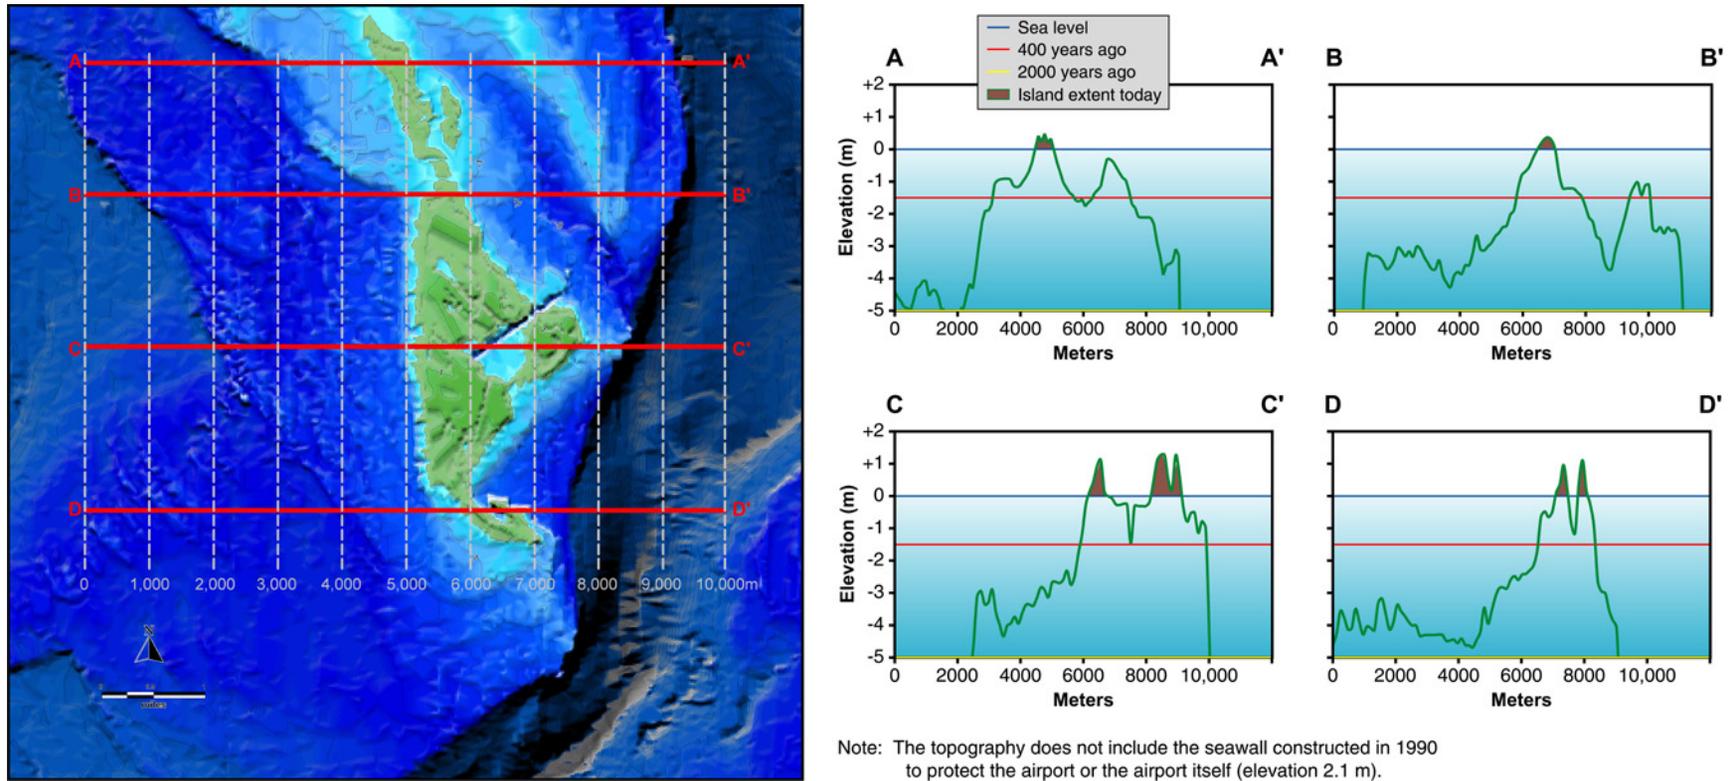
Figure 5. Bathymetry surrounding Tangier Island and topographic relief of the island.

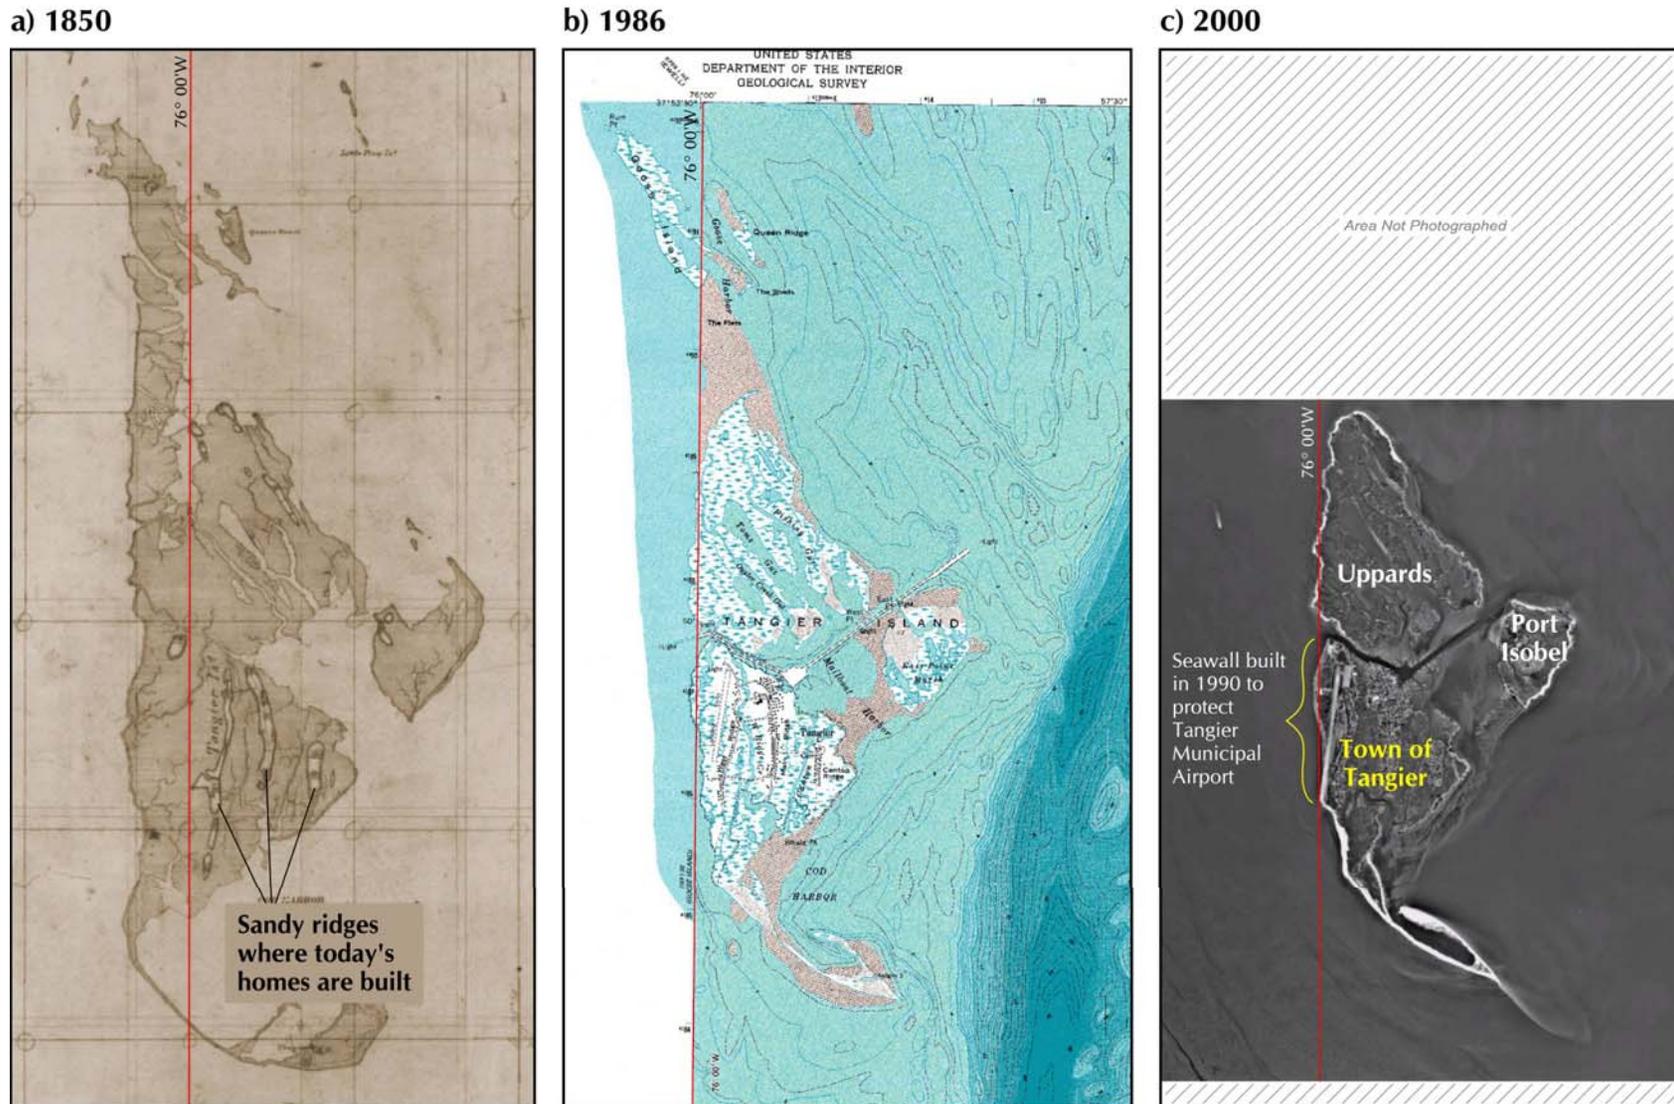
Figure 6. Extent of Tangier Island in 1850, 1986, and 2000.

Figure 6a shows a map of the island drawn in 1850. While earlier maps exist, such as these drawn by Captain John Smith (Global Sales Publications, 1996) in the 17<sup>th</sup> century and Fry and Jefferson in the 18<sup>th</sup> century (Fry and Jefferson, 1791), this appears to be the first accurately drawn map. Three sandy ridges are identified on the island, locations where homes have been built and remain today. A 1986 USGS topographic map shown in Figure 6b identifies the three ridges (West Ridge, Main Ridge, and Canton Ridge), and homes built on each of these three ridges. Note that the island has been bisected by a channel (Tangier North Channel) that is routinely dredged to maintain navigational integrity. The 76° 00' W meridian shown in both Figure 6a and 6b helps to provide a marker to quantify the amount of shoreline erosion that occurred between years 1850 and 2000. Quantification of the erosion rate is provided subsequently in this paper.

In Figure 6c, an aerial photograph of the island, taken in March 2000 by the United States Army Corps of Engineers (USACE) is shown. The Tangier Island Municipal Airport on the western side of the main island can clearly be seen, and has been extended since 1986. Also, a seawall was constructed by the USACE in 1990 to protect the airport from the eroding shoreline. The extent of the seawall is indicated in the figure.

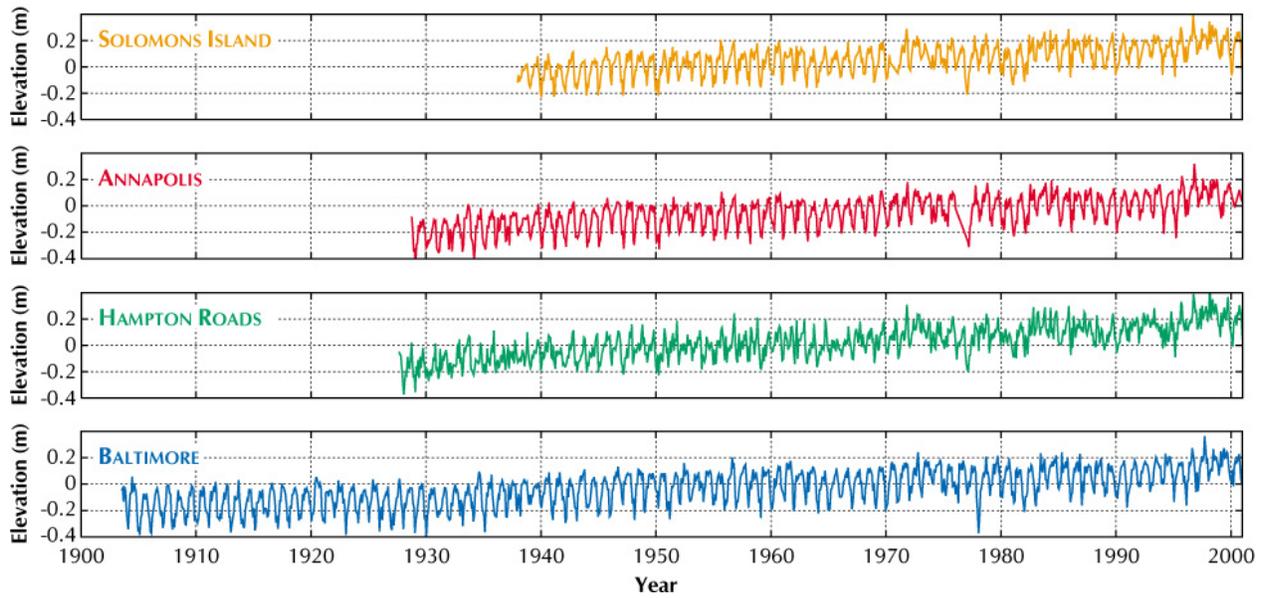
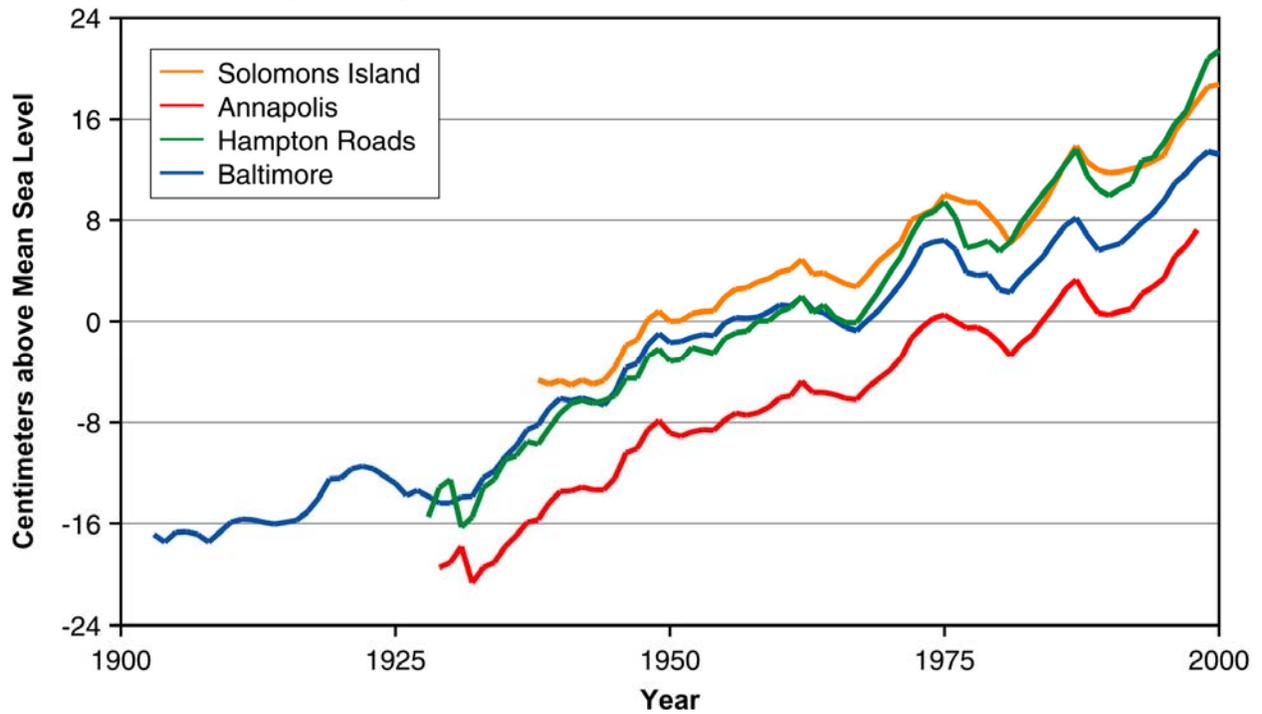
a) Monthly

b) Five Year Running Averages

Figure 7. 20<sup>th</sup> century sea level changes in Chesapeake Bay.

Figure 7a shows 20<sup>th</sup> century relative sea level changes at four locations throughout the Chesapeake Bay based on tide gage information obtained from the Permanent Service for Mean Sea Level (PSMSL) (Proudman Laboratory, 2002). The locations were selected both for their spatial distribution and long periods of records (over 60 years at Solomons Island to over 95 years at Baltimore). Note the general similarities in trends at the four locations. Averaged over a century, the relative sea level increases from 31 cm/century at Baltimore to 38 cm/century at Solomons Island. These rates are about twice the rates of global sea level increase (approximately 15-20 cm/century) as discussed earlier. Subsidence in the Chesapeake Bay area has been estimated to be about 18 cm/century (Kearney and Stevenson, 1991). Major causes of the large-scale subsidence includes post-glacial response of the land following the last Ice Age over 15,000 years ago and tectonic activity of the earth's crust. Removing the subsidence from the recent relative sea level increases would indicate that the global sea level increase is about 13 cm/century to 20 cm/century, within estimates of global sea level rise provided by IPCC (2001). Figure 7b shows five-year running averages at four locations within the Chesapeake Bay. Similarities between stations are evident and long-term fluctuations are apparent (and similar) in all records. These dramatic fluctuations illustrate the risk of using short-term records to estimate rates of sea level change.

In addition to the long-term trend in sea level, it is seen from Figure 7a that the sea level changes cyclically over each year. A power analysis was performed of the data to examine this periodicity. The results are shown in Figure 8. Sea levels exhibit a strong annual cycle. The maximum sea levels typically occur during the summer months, and the minimums occur during the winter. These patterns are caused by both thermal expansion (summer) and contraction (winter) when the water temperatures change from about 28 °C to 5 °C, respectively, and by changes in volumes of freshwater in the Bay due to seasonal runoff, where often peaks in runoff rates often occur at two different times during the year.

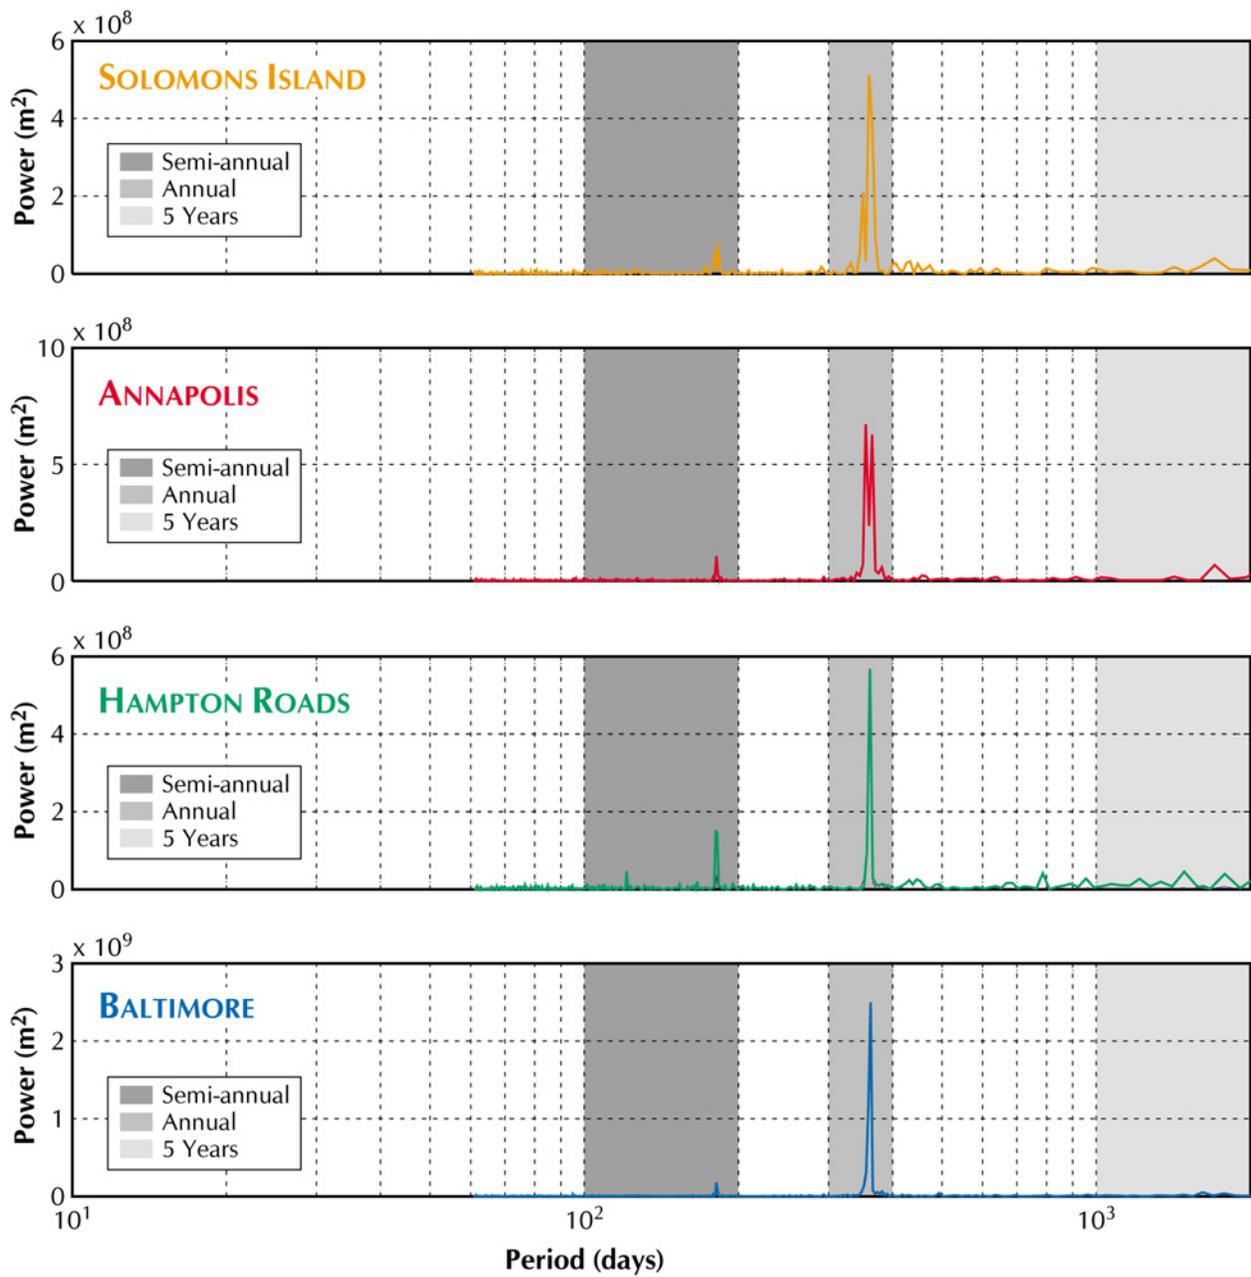
Figure 8. Major periodicities associated with sea level changes in Chesapeake Bay.

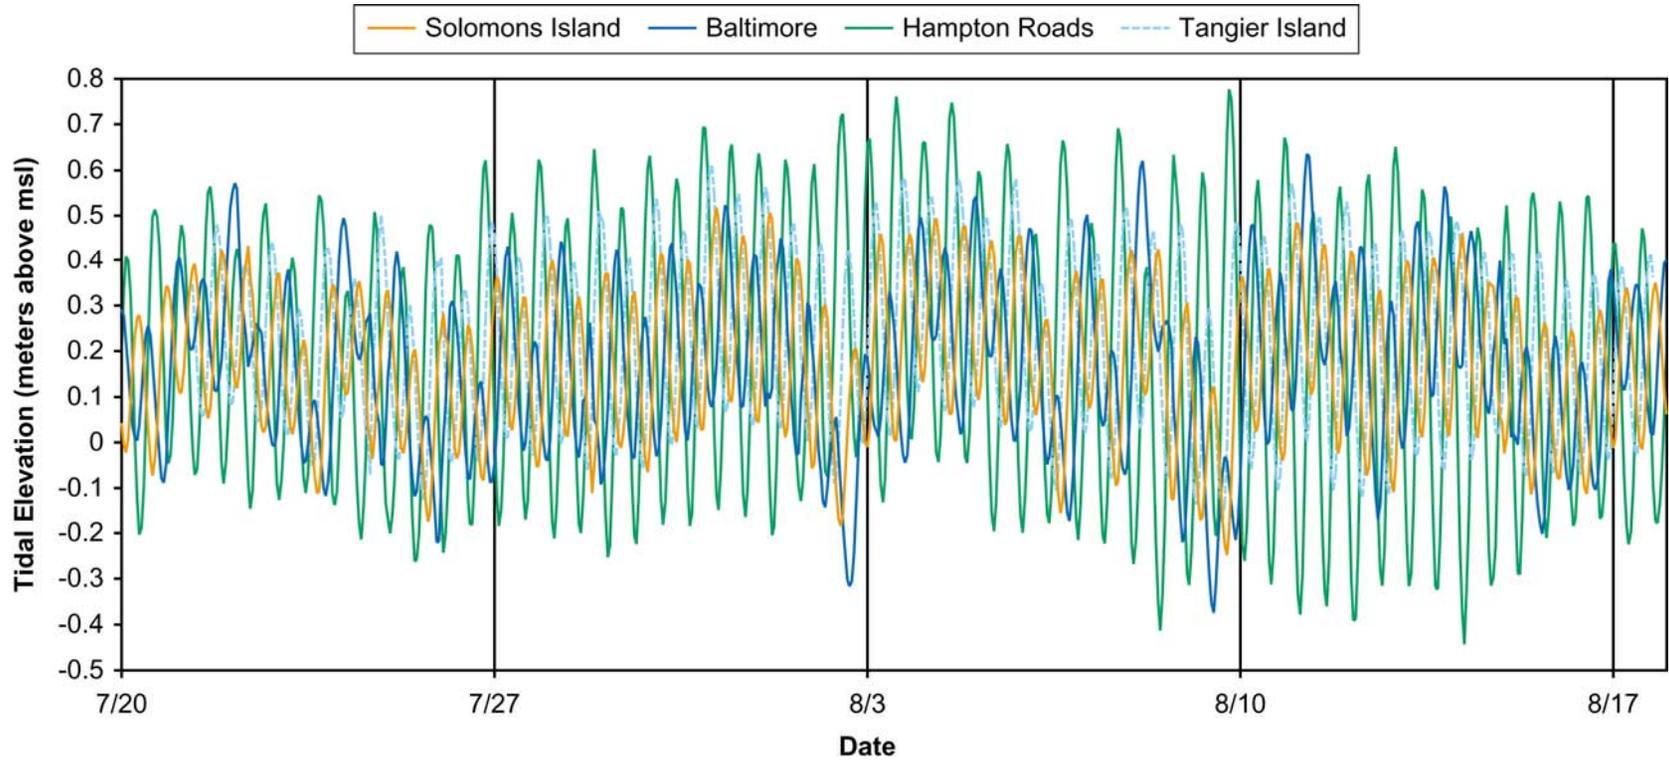
Figure 9. Tidal elevations in the Chesapeake Bay during July - August 1999.

While long-term sea level data are not available for tide gages located on Tangier Island, some limited hourly tidal data are available. One month of tidal data in July and August 1999 was plotted against the tidal data for Hampton Roads, Solomons Island, and Baltimore (Figure 9). The data indicate that the tidal range is considerably greater near the mouth of the Bay at Hampton Roads than further up the Bay. The ranges at both Solomons Island and Baltimore are similar to that at Tangier, although the phase has shifted. Since the phase is immaterial for this study, tidal data for both Solomons Island and Baltimore are used in subsequent analyses.

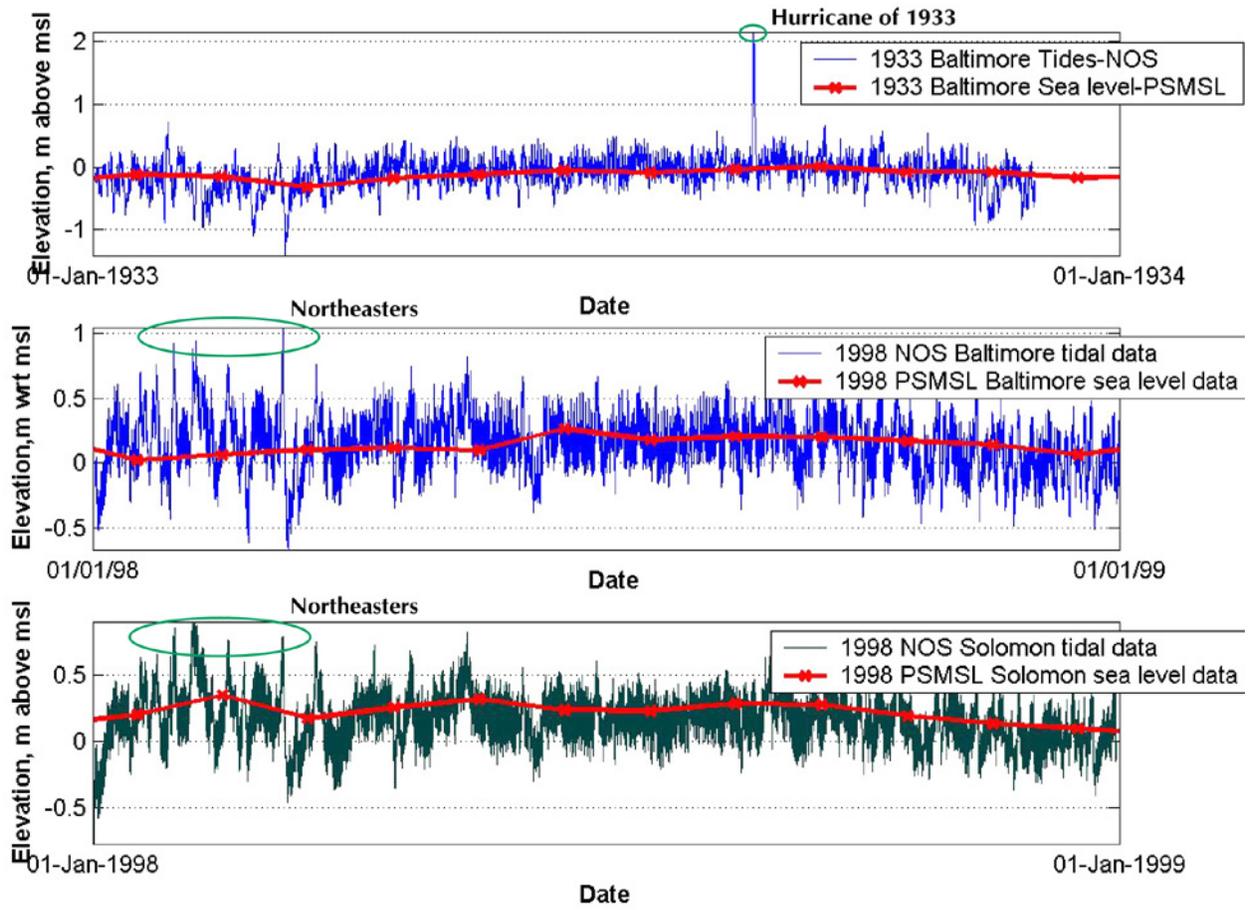
Figure 10. Sea level and tidal time series at locations in Chesapeake Bay.

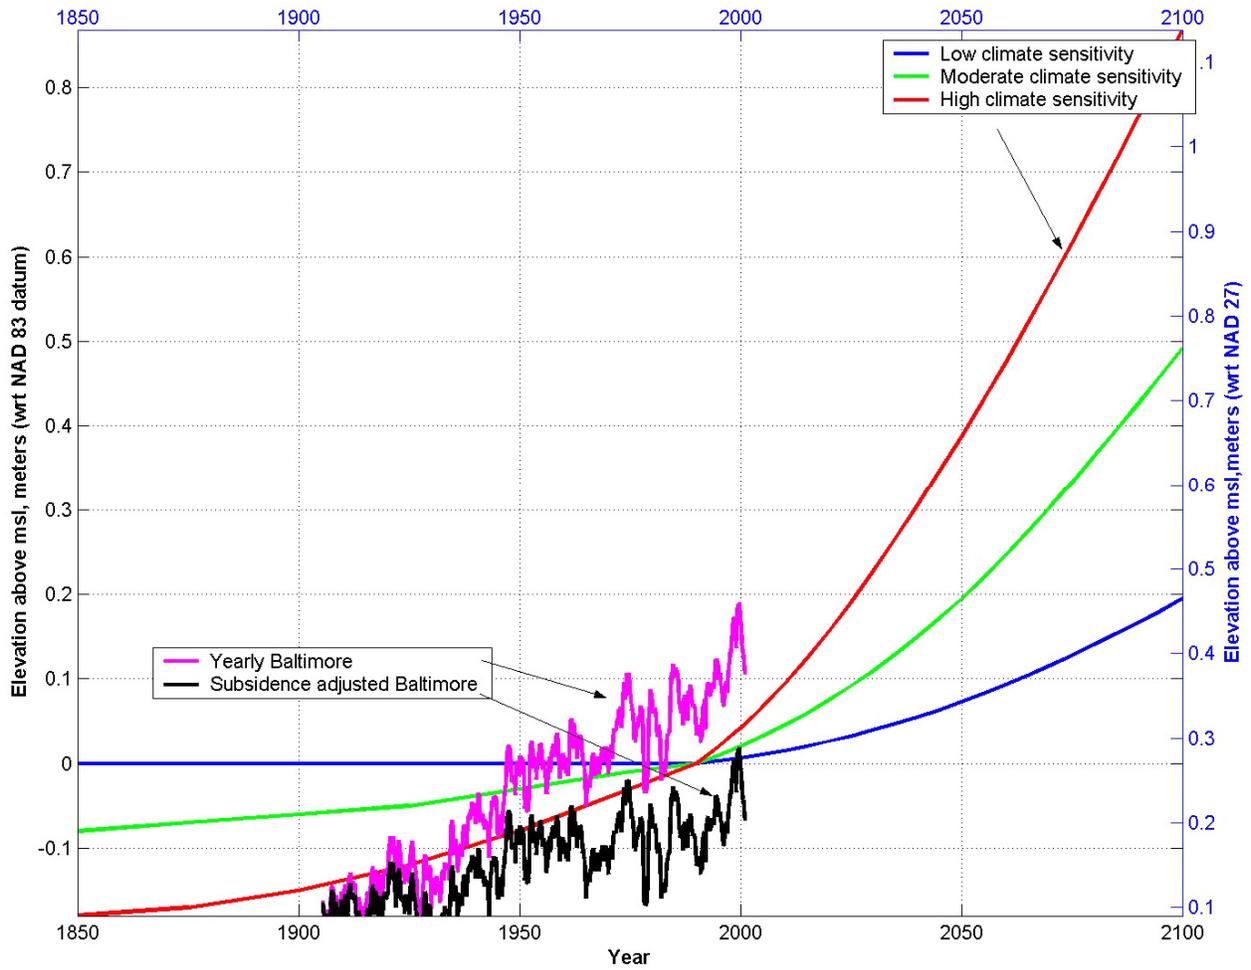
Figure 11. Range of estimated sea level changes over the 21<sup>st</sup> century and observed values over the 20<sup>th</sup> century.

To extrapolate sea levels to the year 2100, the model MAGICC (Hulme et al., 2000) was used, and simulations were performed under low, moderate, and high climate sensitivities. Sensitivity refers to the global temperature change that results from a doubling in atmospheric greenhouse gas concentrations, at attainment of an equilibrium condition. The model results are shown in Figure 11, along with the time series of sea level changes at Baltimore with and without adjustment for subsidence. It is seen that the relative rate of sea level increase without adjusting for subsidence is similar to the present rate of global sea level increase for high climate sensitivity, while the relative rate adjusted by removing subsidence is closer to the low sensitivity rate. In turn the low sensitivity rate is close to the historical rate of 15-20 cm/century, as depicted by the blue line that extends over the 21<sup>st</sup> century.

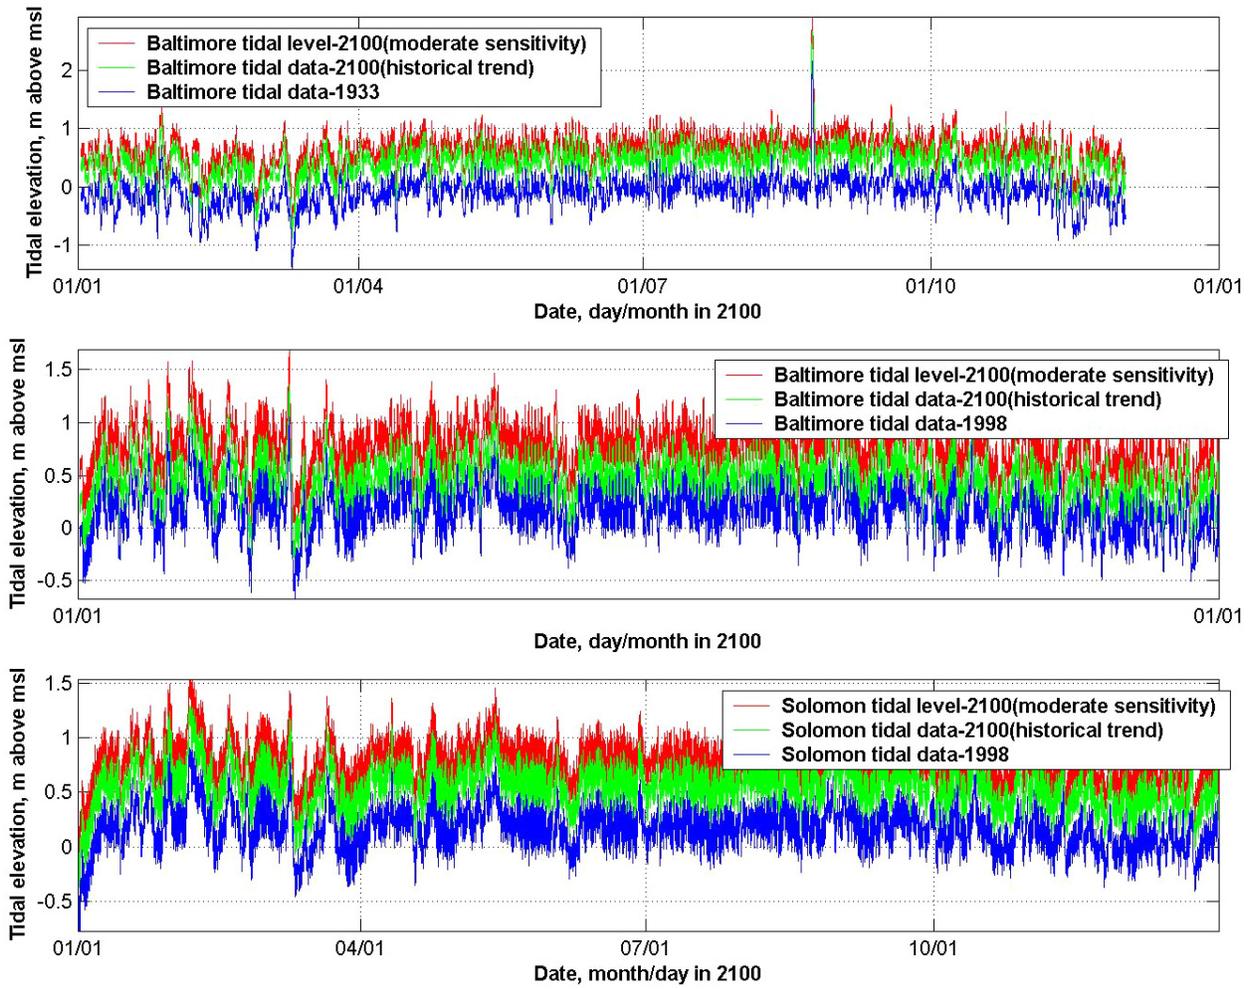
Figure 12. Projected tides in the year 2100 from historical tides in 1933 and 1998.

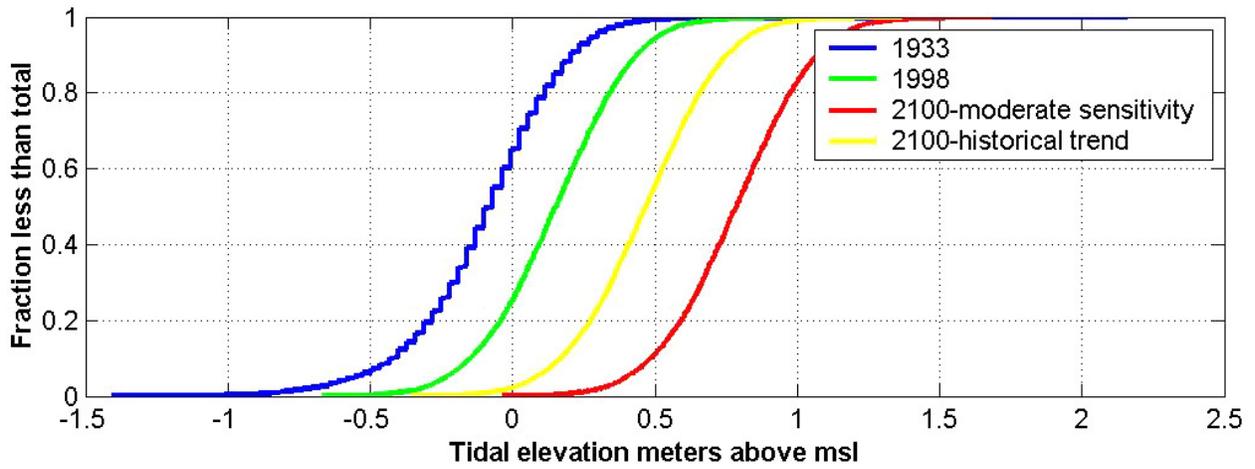
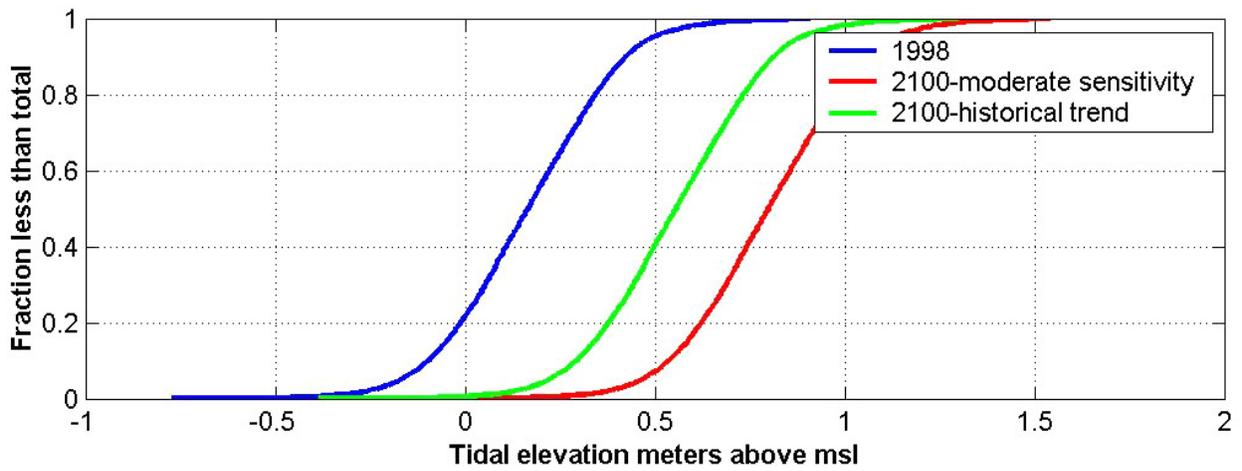
Figure 13. Cumulative distribution of tides: 1933-2100.

To interpret the results of rising sea level, Figures 13, 14, and 15 were prepared. In Figure 13 yearly tidal data, both historical and predicted, were sorted from low to high and plotted as cumulative distribution functions. The tidal elevations are shifted to the right with increasing time (that is, from 1933 to 1998 to 2100) and with increasing climate sensitivity (low sensitivity, essentially a continuation of the historical trend, and moderate climate sensitivity). In Figure 13a (based on Baltimore records), the historical relative sea level rise from 1933 to 1998 is shown by the two left most curves. Over this time interval (65 years) the historical relative sea level has increased by about 20 cm, as measured by the 50th percentile tides. This is equivalent to about 31 cm/century. Predictions for the

year 2100 show that the median tidal level will increase by about 30 cm (continuation of historical trend) to 60 cm for moderate climate sensitivity. Figure 13b is a similar plot for Solomons Island, but includes a shorter time frame, 1998-2100. The predicted sea level increases are very similar to those in Figure 13a.

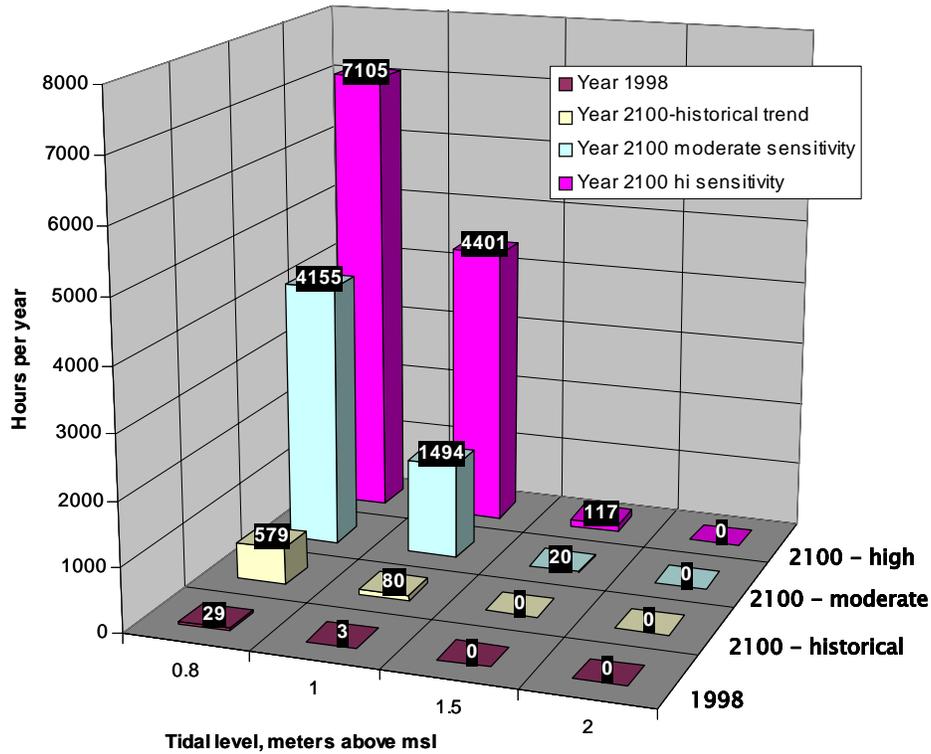
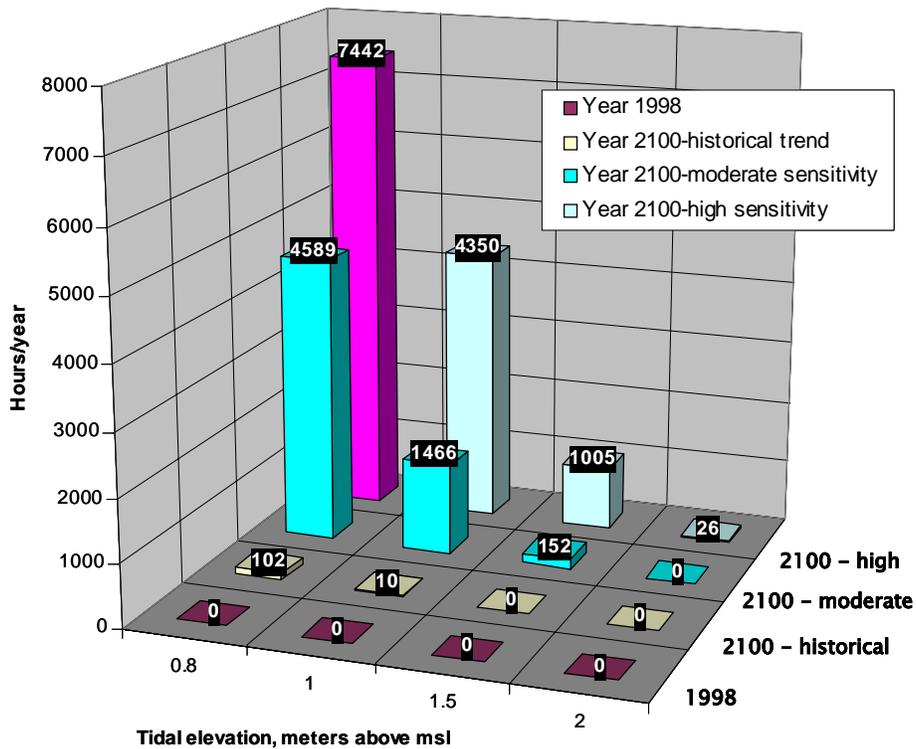
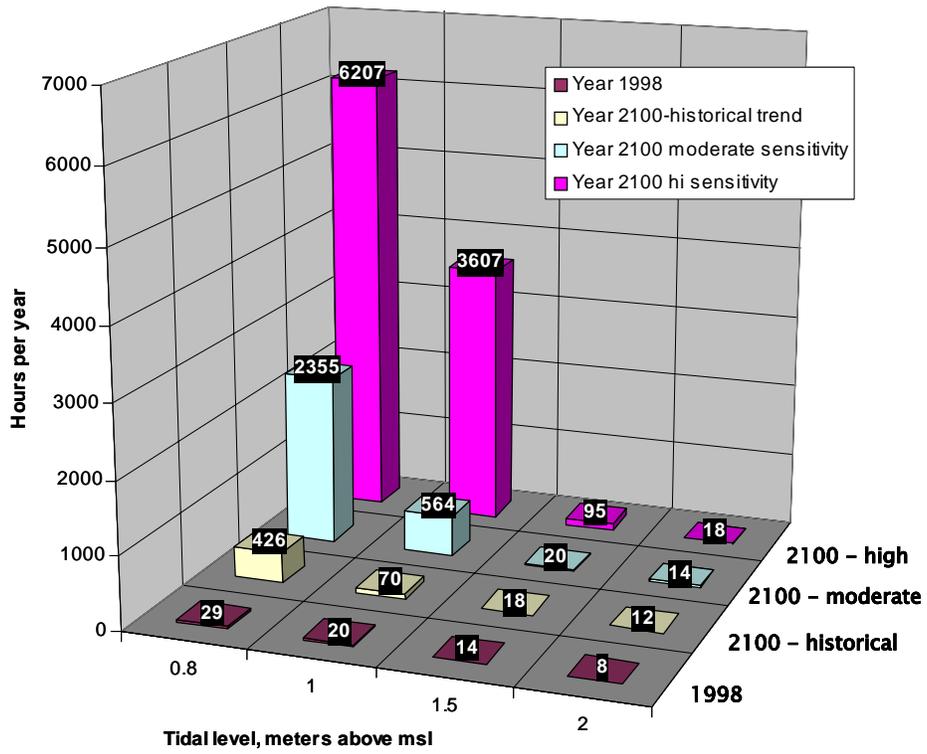
Figure 14. The number of hours per year when tidal elevations exceed specified levels.

In terms of predicting impacts on the human population of the island, Figure 14 has been prepared that shows the amount of time per year that certain critical tidal elevations are exceeded. Figure 14a uses the 1998 Baltimore data as the base year, Figure 14b is based on using 1998 Solomons Island data as the base year, and Figure 14c is based on using 1933 Baltimore data as the base year. Each figure uses the elevations of 0.8 m, 1.0 m, 1.5 m, and 2 m above msl. When the tidal elevation is 1 m to 1.5 m above msl, the ridges on which the houses are built begin to flood, as the elevations of these ridges are about 1 m above msl. When the tidal level is greater than 2 m above msl the entire island is underwater. In 1998 the tidal elevation was 1 m above msl for only 3 hours of that year (Figure 14a). Extrapolating to the year 2100 for either a continuation of the historical trend or for moderate climate sensitivity, the 1 m elevation would be exceeded much more, 80 hours to 1494 hours, respectively. For the high climate scenario, the 1 m above msl elevation would be exceeded about 4400 hours, or 50 percent of the time. Very similar results are obtained using the 1998 Solomons Island data (Figure 14b). Figure 14c uses the year 1933, the year of the unnamed hurricane, as the base year. The major difference in using this year is that tidal elevations would exceed 2 m above msl, in which case the island would have been underwater for 8 hours in 1998, increasing to 12-18 hours in the year 2100 depending on the rate of sea level rise.

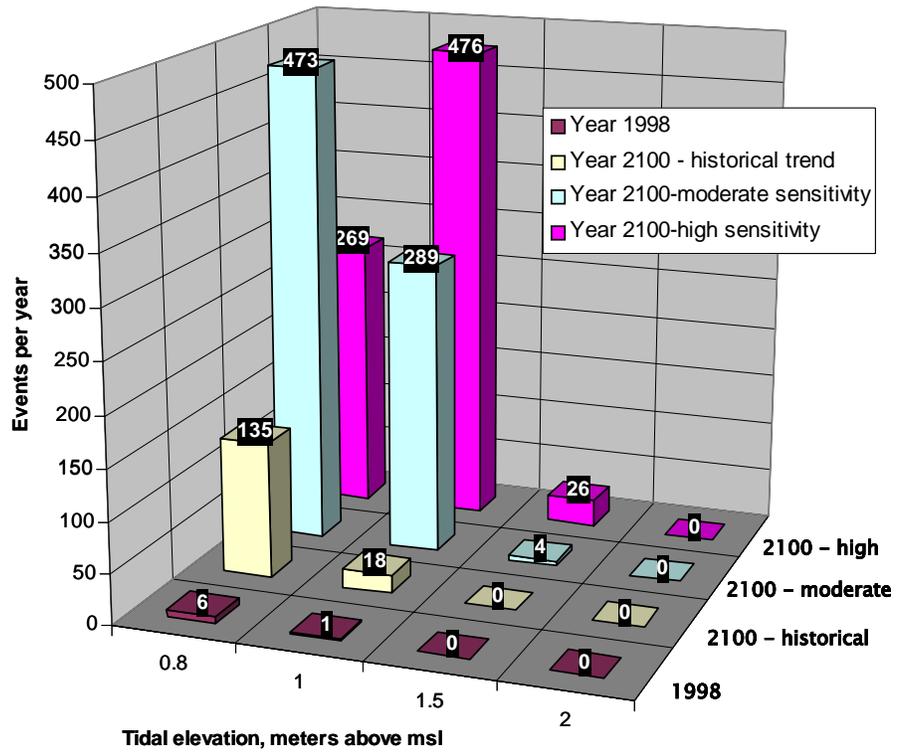
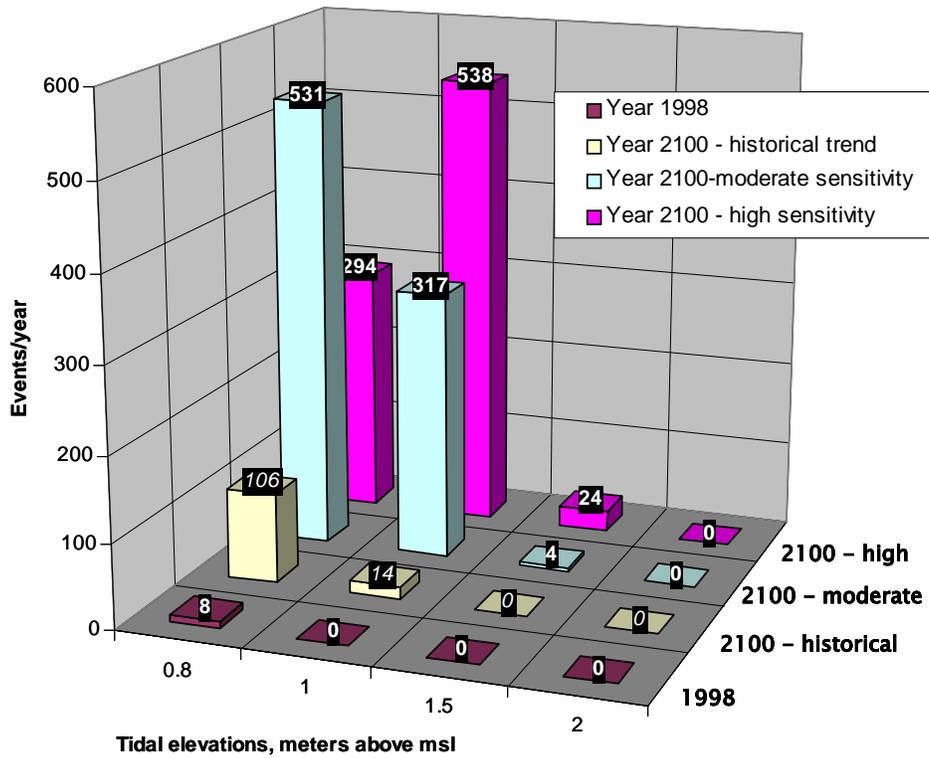
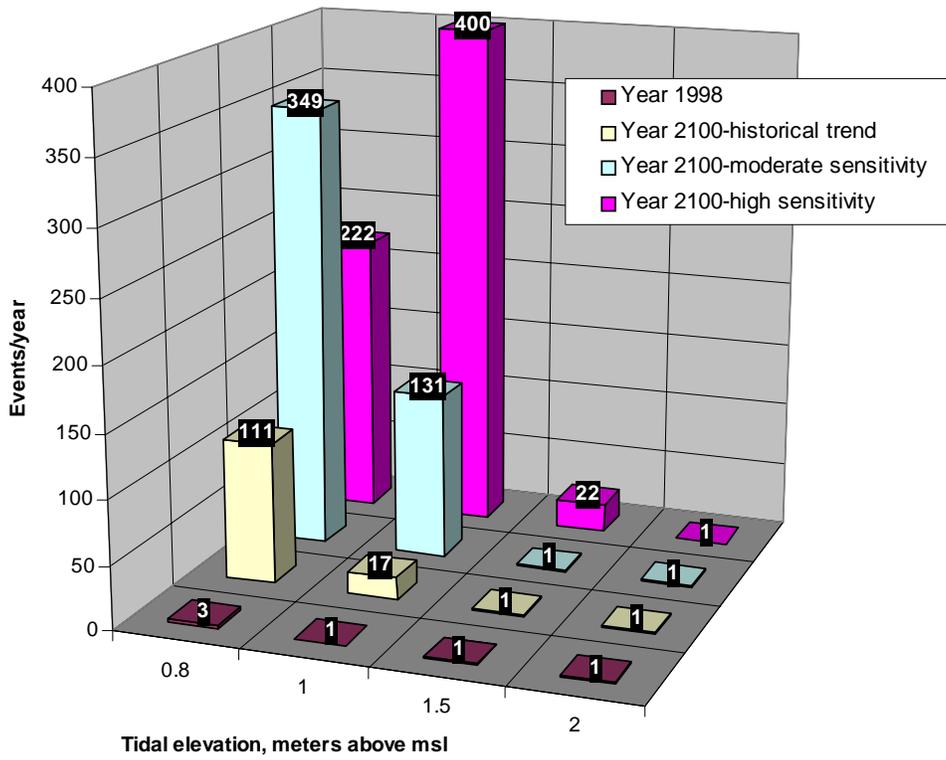
Figure 15. Events per year at Tangier Island when tidal elevations exceed the levels shown.

Figure 15 shows the number of predicted events during the year when the tidal elevations would be above the levels indicated. Each event is defined to begin when the tide reaches a specified level, and continues until the tide recedes below that level. The number of events when tides exceed 1 m above msl would increase dramatically for the year 2100 for both the moderate and high climate sensitivity cases, regardless of which data are used in the extrapolation. Note at the lower limit of tidal elevations used in Figure 15 (0.8 m above msl), the number of events at the high climate sensitivity actually decreases relative to the number of events at moderate sensitivity. This is due to the increased duration of each event.
