# PREDICTIONS OF RELATIVE SEA LEVEL CHANGE AND SHORELINE EROSION OVER THE 21<sup>ST</sup> CENTURY ON TANGIER ISLAND, VIRGINIA

## ABSTRACT

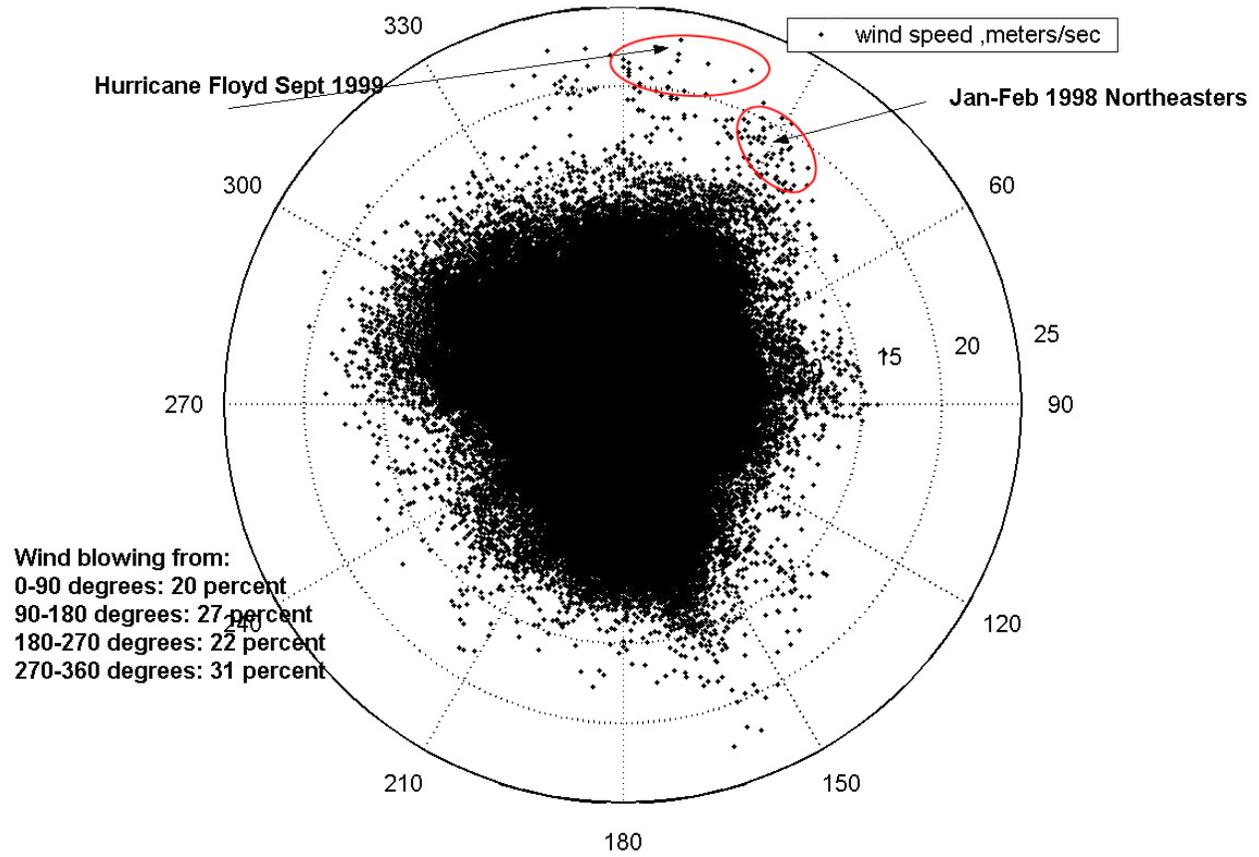
Figure 16. Wind speed and direction (degrees from) for 1997-2001 data at TPLM2, 60 km north of Tangier Island.

As shown below, the erosion is worst on the western side of the island, where the island is exposed to longer stretches of open water, and wind generated waves are larger. Figure 16 shows a polar plot of wind speed and direction at a location 60 km north of Tangier Island for the five years 1997-2001. Also identified on the plot are a hurricane (Hurricane Floyd) and northeaster that occurred during this time period, which were responsible for some of the highest wind speeds. Analysis of the data show that the wind blows from 270° - 360° 31 percent of the time (the most of any quadrant), and from 0° - 90° 20 percent of the time (the least of any quadrant). Figure 17 shows the distribution of wind speeds by quadrant. When the winds are blowing from 270° to 360°, they typically blow harder than when blowing from the other quadrants.

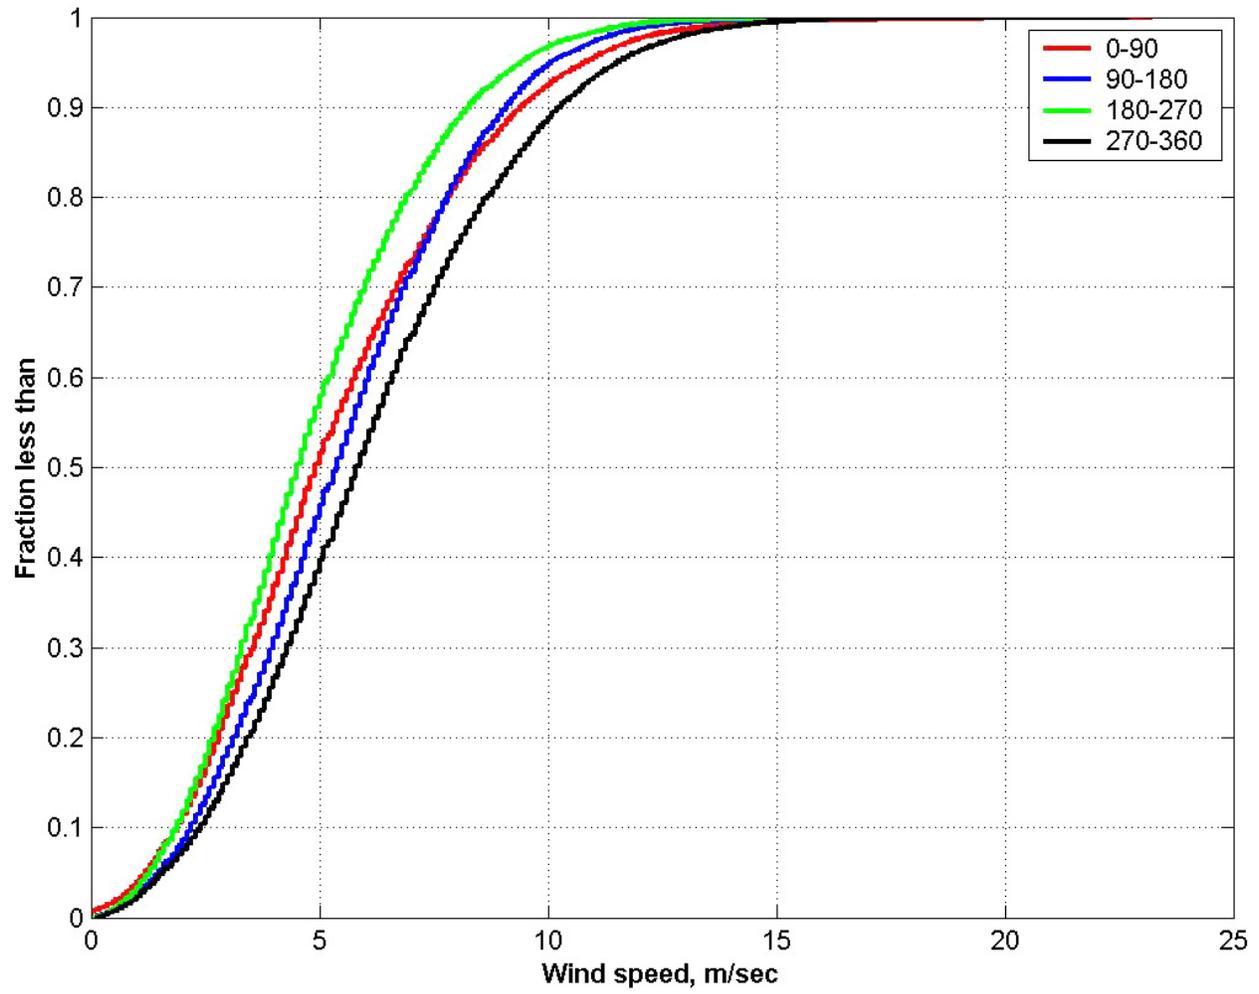
Figure 17. Wind speeds by quadrant for 1997-2001.

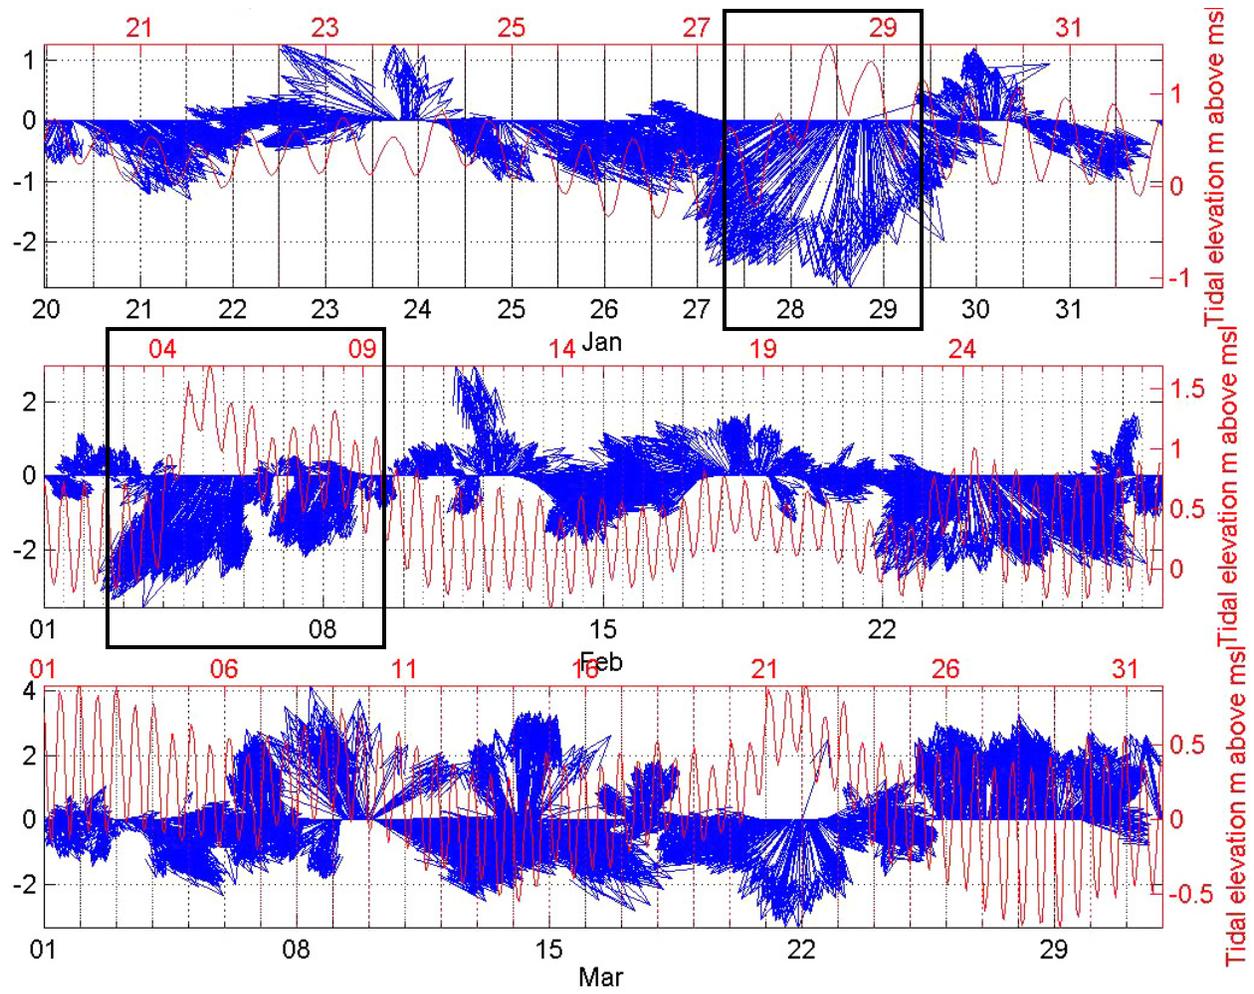
Figure 18. Response of tidal elevations in Chesapeake Bay to wind speed and direction, January - March 1998.

Figure 18 illustrates typical relationships between wind speed and direction, and tidal height. During northeasters (low pressure systems) the tidal heights tend to increase, as shown earlier in Table 1, and illustrated in Figure 18. When the wind direction shifts to the northeast the tides increase accordingly, as more water is pushed into the Bay during this time. Two different northeasters are boxed in Figure 18: the first around January 28, 1998 and the second around February 4-5, 1998. Both illustrate how the tidal elevation increases as the wind blows from the northeast.

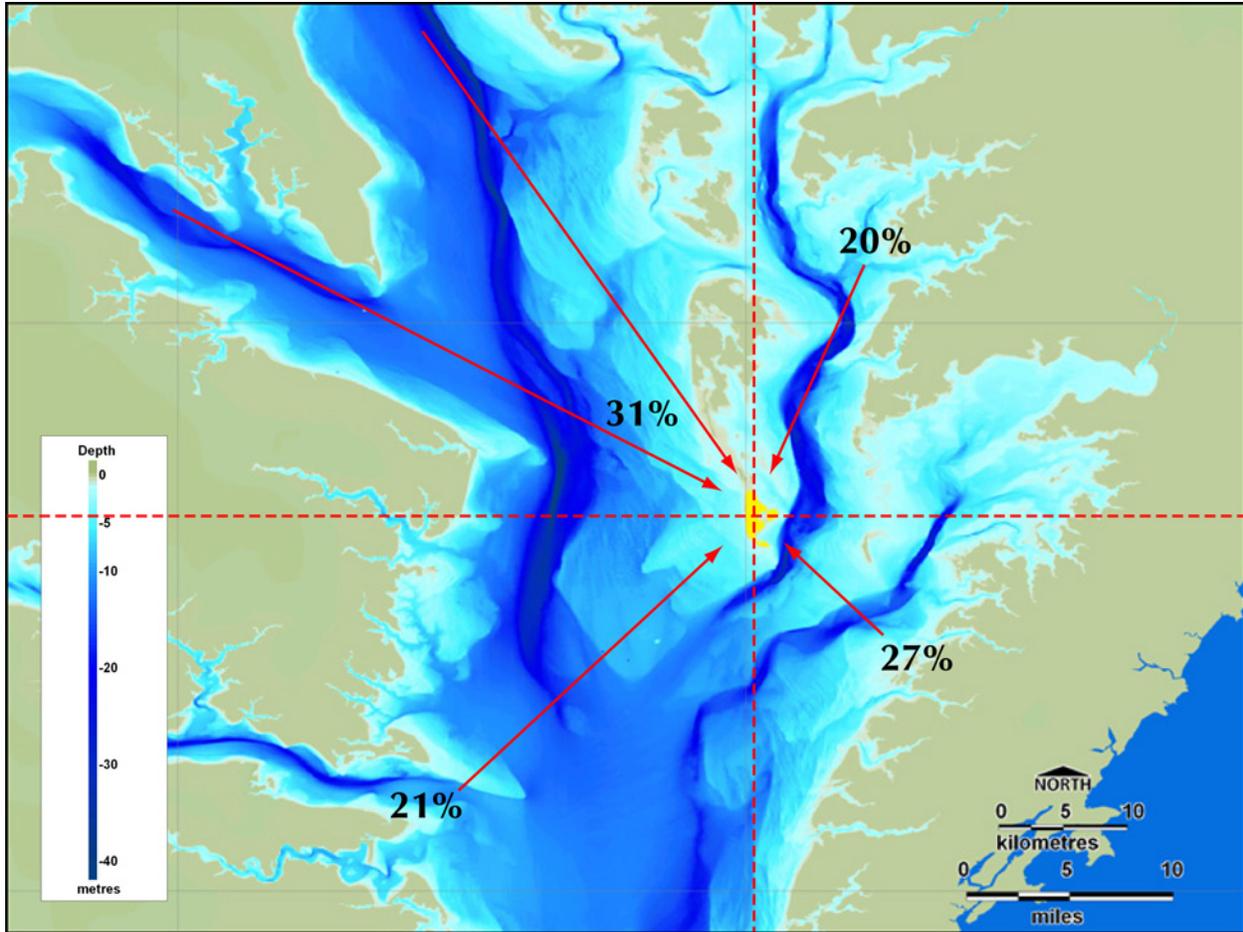
Figure 19. Illustration of percent of time winds blow from each quadrant and approximate fetch denoted by lengths of arrows with respect to Tangier Island.

Figure 19 illustrates the fetch by direction at Tangier Island. The longest fetches are to the northwest of Tangier, which is also the direction from which winds blow more often, and at higher speeds. Figure 20 shows how fetch influences wave height. In that figure, predicted wave heights are shown as a function of water depth and wind speed for two different fetches (42 km and 20 km). These fetches are representative of open-water distances from the northwest and from the east, respectively. Wave heights of up to 80 percent higher result from the longer fetch. For example at a water depth of 30 m and wind speed of 20 m/sec, the predicted wave heights at fetches of 42 km and 20 km are 2.7 m and 1.9 m, respectively. To illustrate combinations of fetch, depth, and wind speeds required to produce waves of two specified heights (1.5 m and 2.0 m) Figure 21 was created. It is clearly seen that conditions for 2 m waves to occur are much more limited than for 1.5 m waves. For example, 2 m waves do not occur for fetches under 25 km, while 1.5 m waves can occur for fetches as short as 13 km.

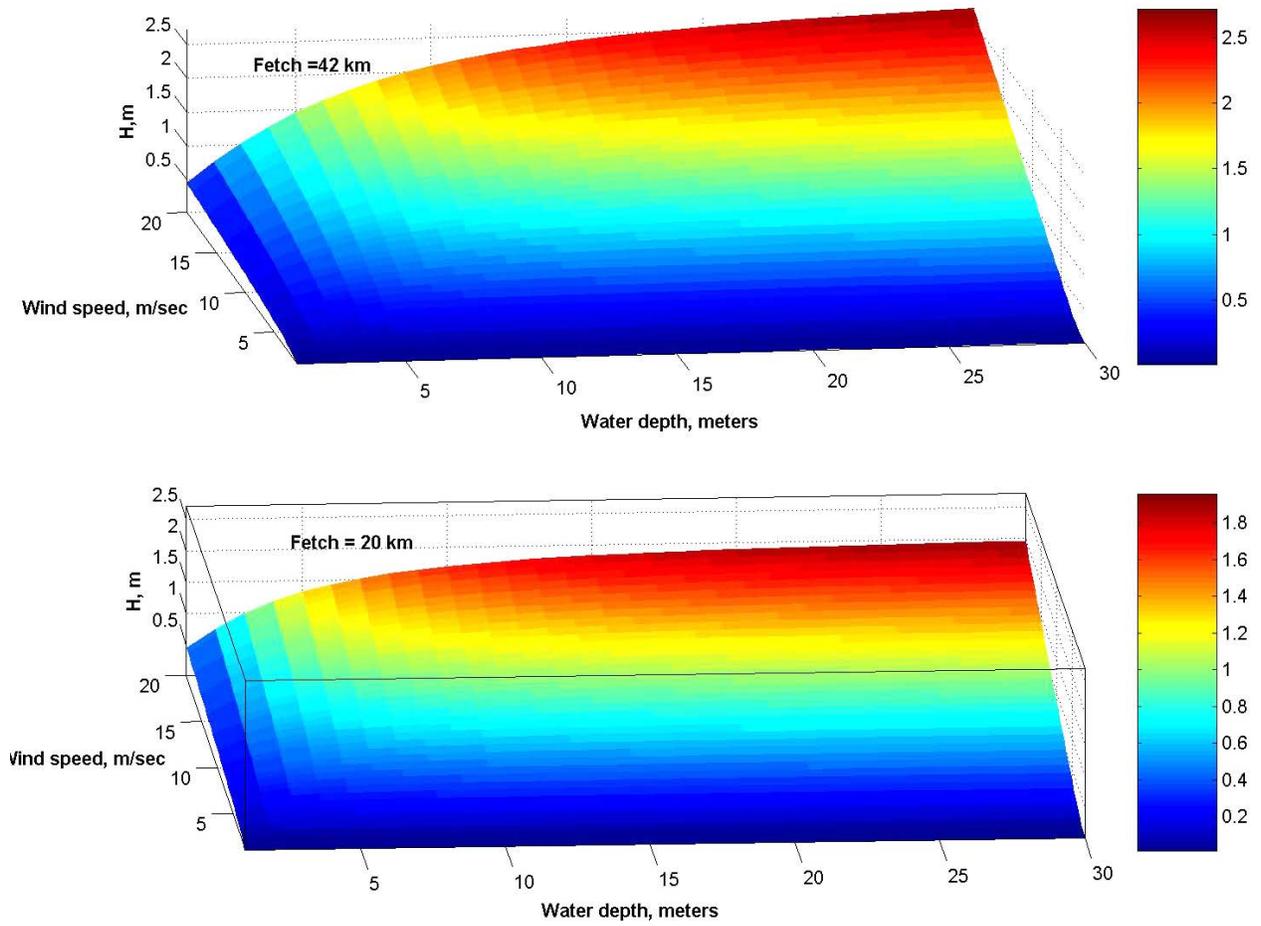
Figure 20. Wave height distributions for two different fetches.

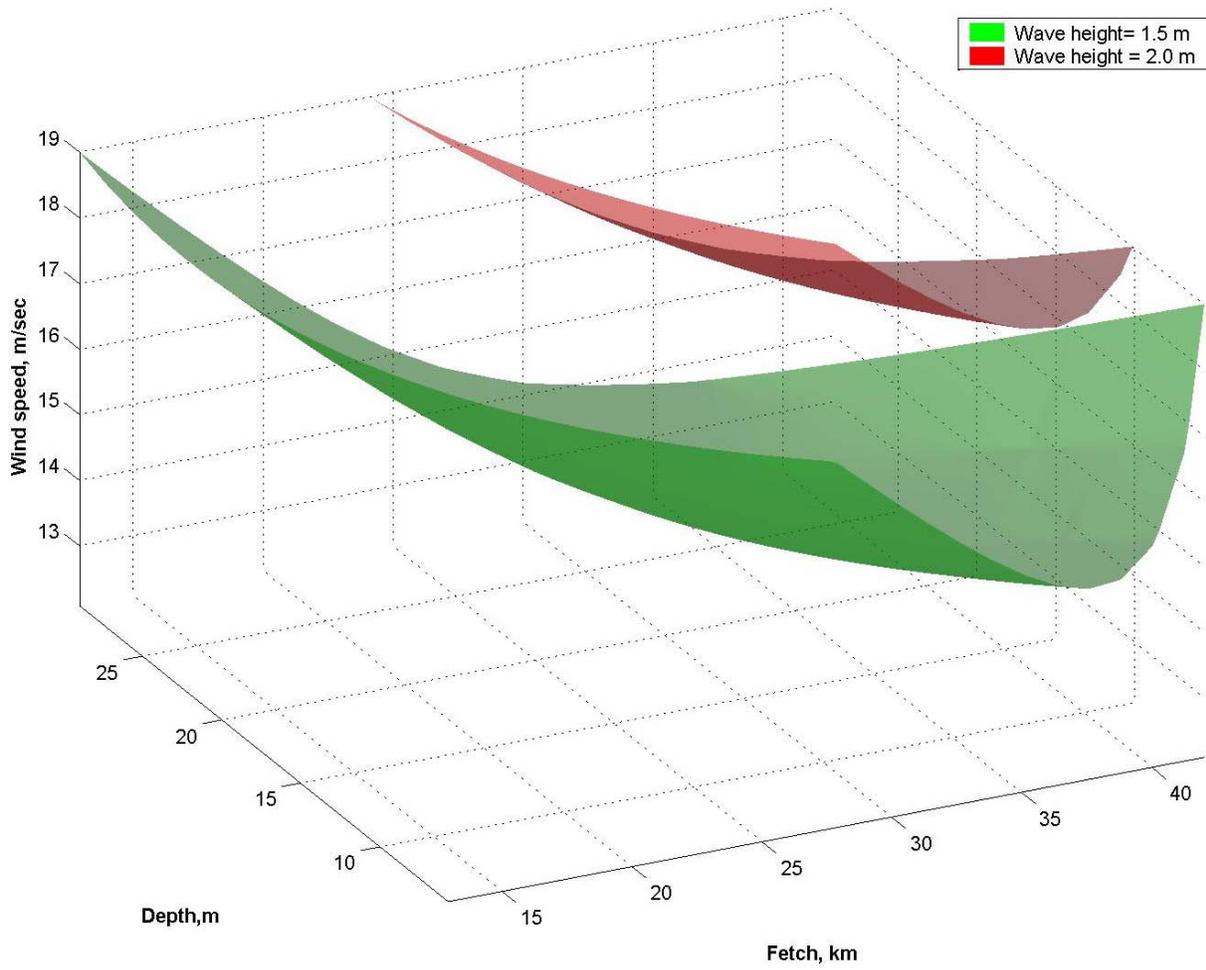
Figure 21. Isosurfaces of two wave heights generated in Chesapeake Bay.

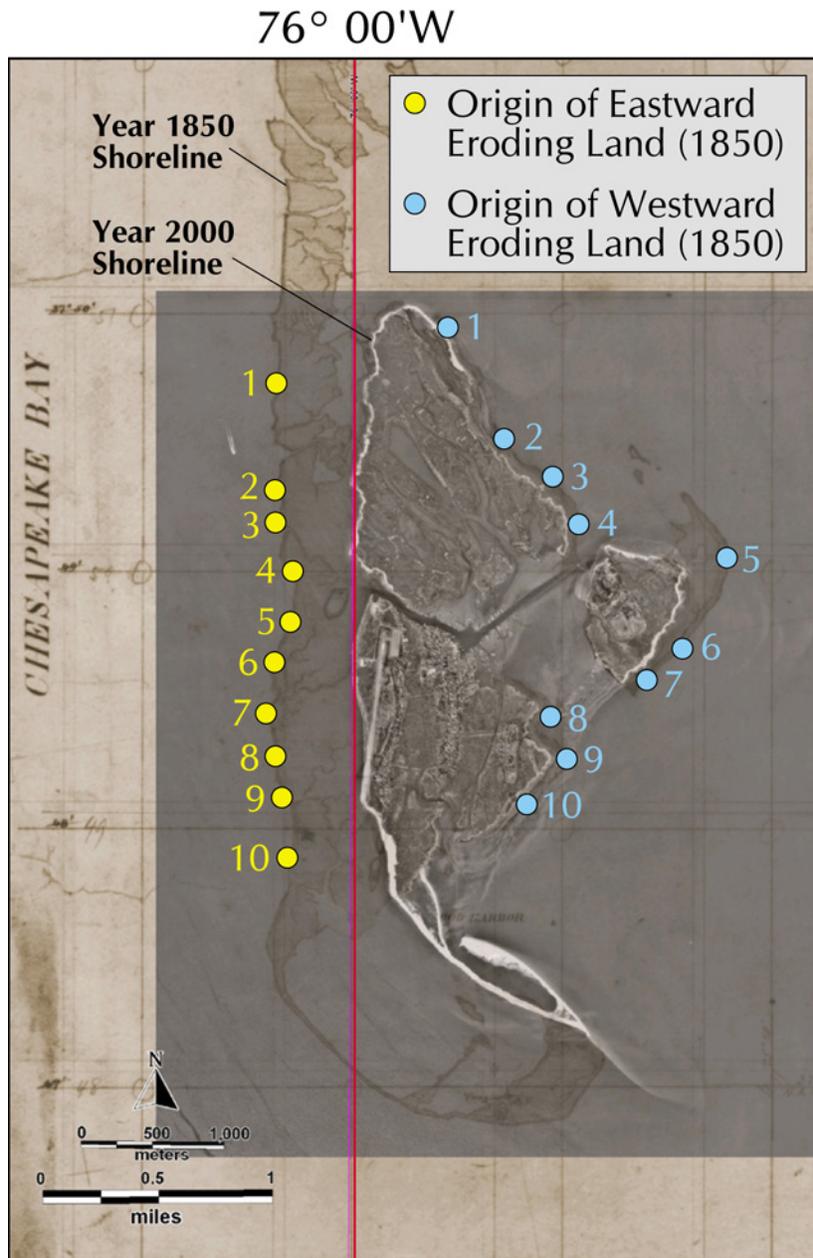
Figure 22. Tangier Island: 1850 vs. 2000.

above-mentioned charts and aerial photographs, the relative change in island size was first visually documented. An example is shown in Figure 22 that compares the island in 1850 to 2000. The  $76^{\circ} 00' W$  meridian was used to assist in aligning the two maps. Practically all of the island west of  $76^{\circ} 00' W$  has been eroded. It is apparent that significant erosion of the western shore has occurred over the past 150 years all up and down the shoreline. The sand spit at the southern end of the island has migrated eastward as the shoreline has eroded and wind has blown the sand eastward. On the eastern side of the island shoreline erosion has also occurred but to a far lesser degree. The effect of the seawall in abating shoreline erosion is shown by examining Figure 6c. Note the erosion that has occurred just to the south of the seawall over the ten years from 1990 to 2000.

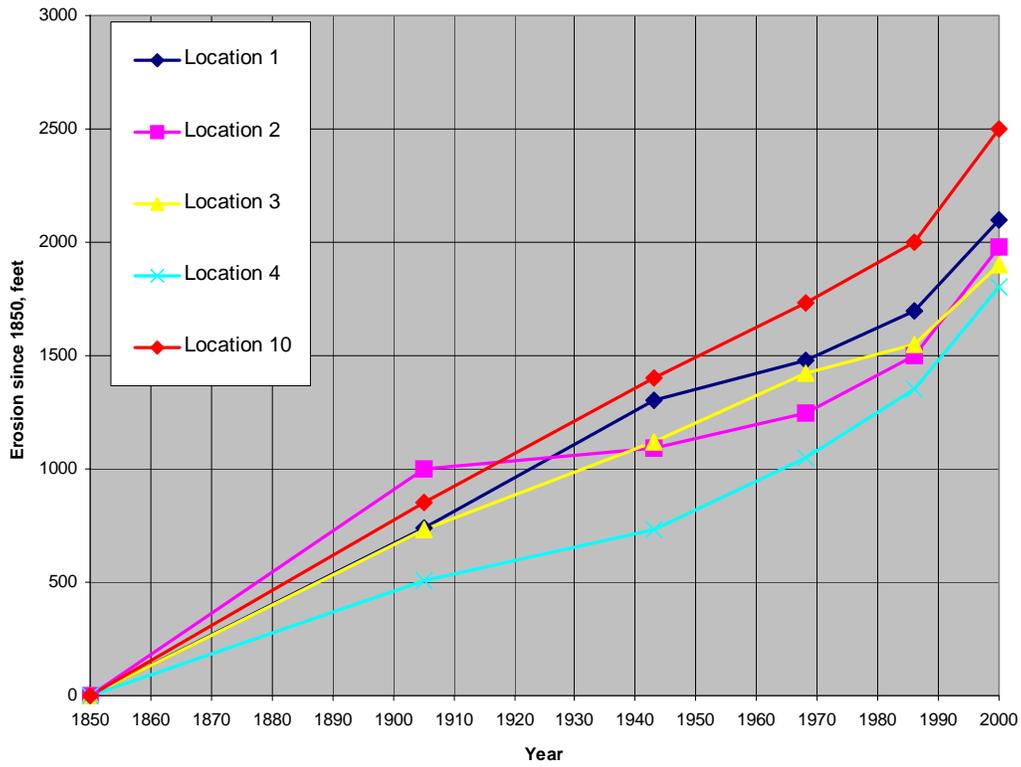
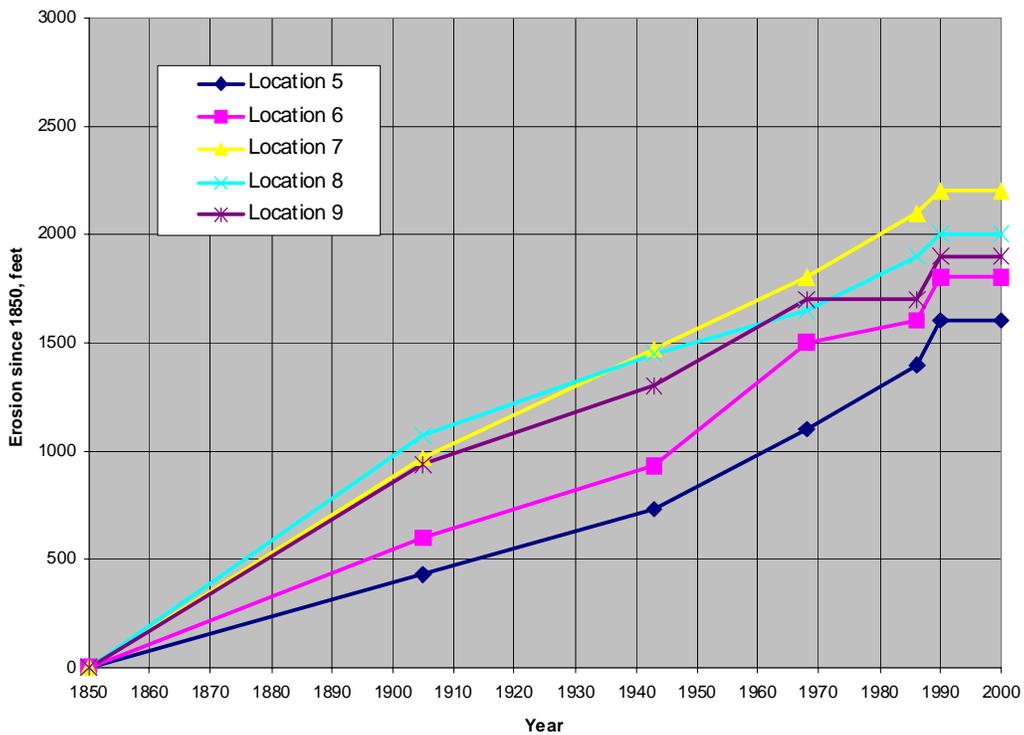
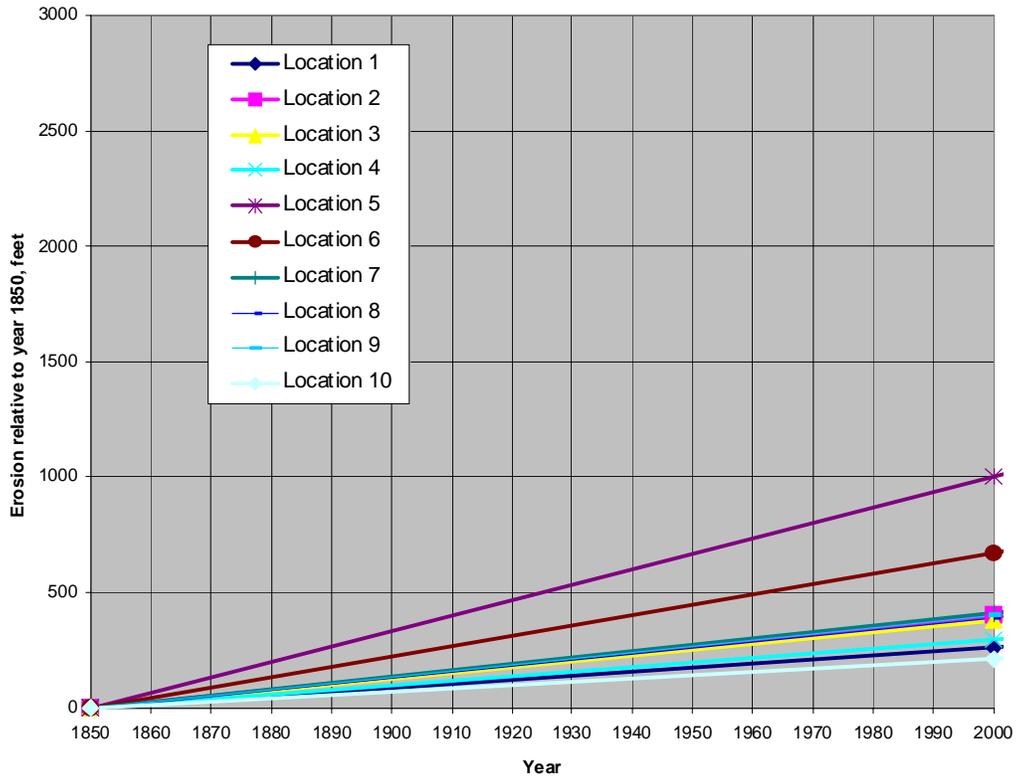
Figure 23. Erosion of shoreline of Tangier Island 1850-2000.

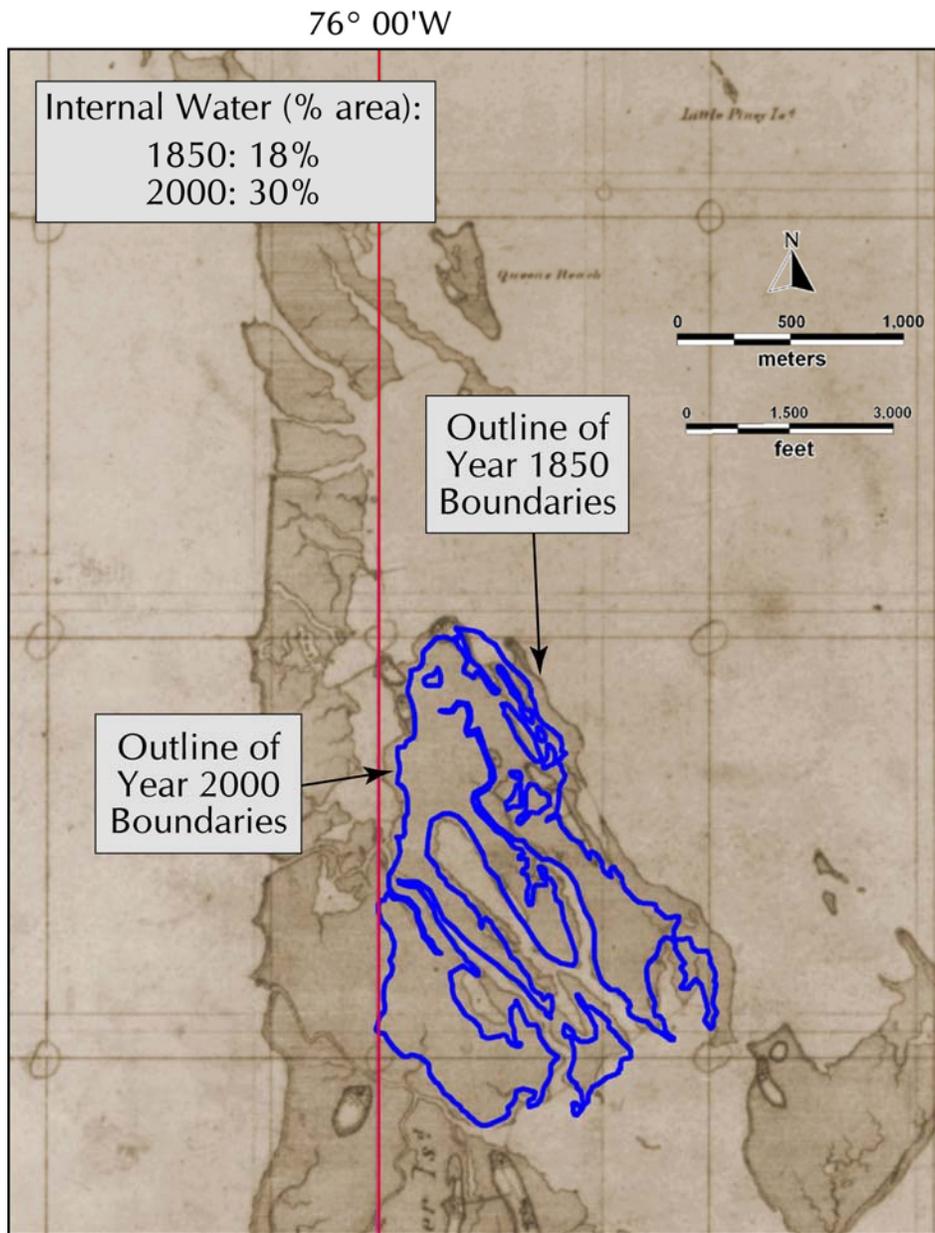
Figure 24. Comparison of internal water on part of Tangier Island: 1850 vs. 2000.

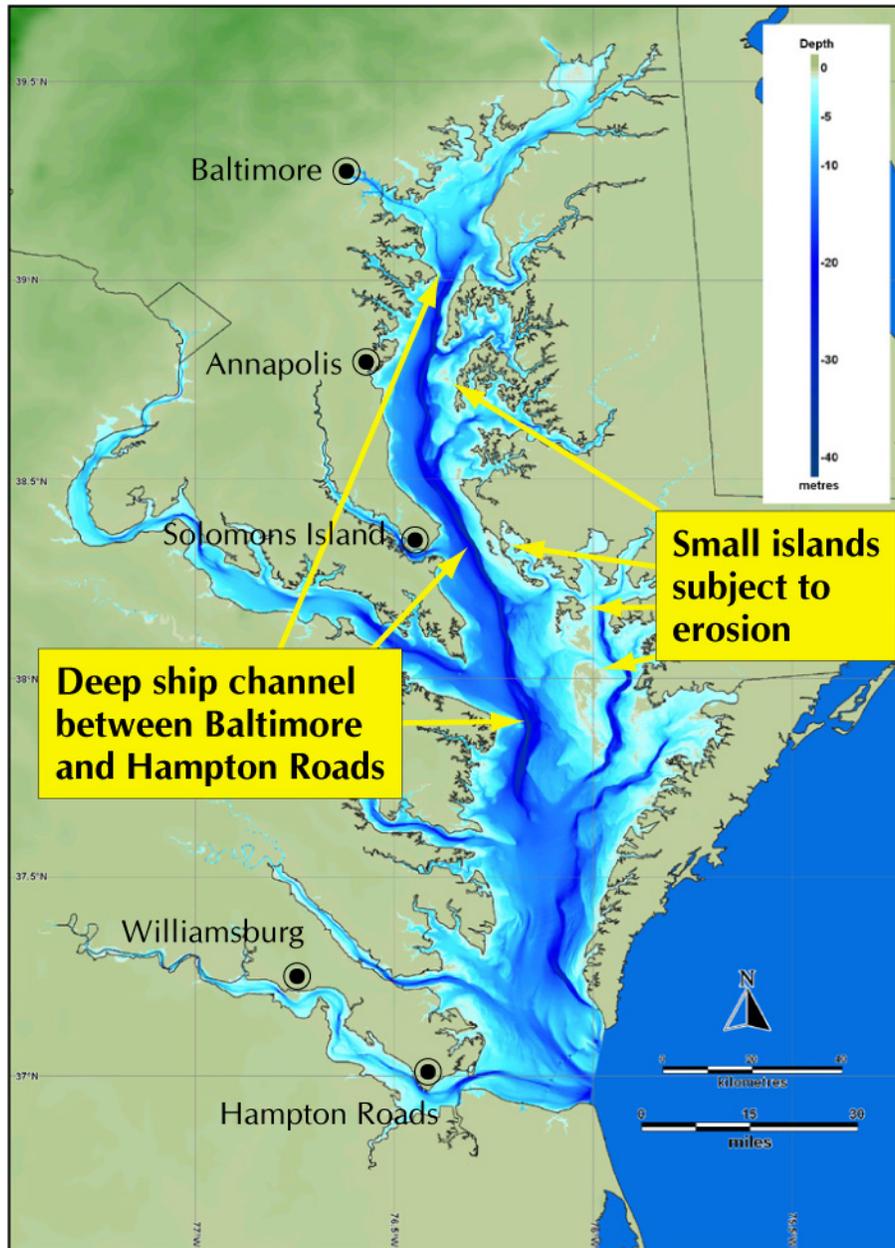
Figure 25. Chesapeake Bay ship channel in relation to small islands within the bay.

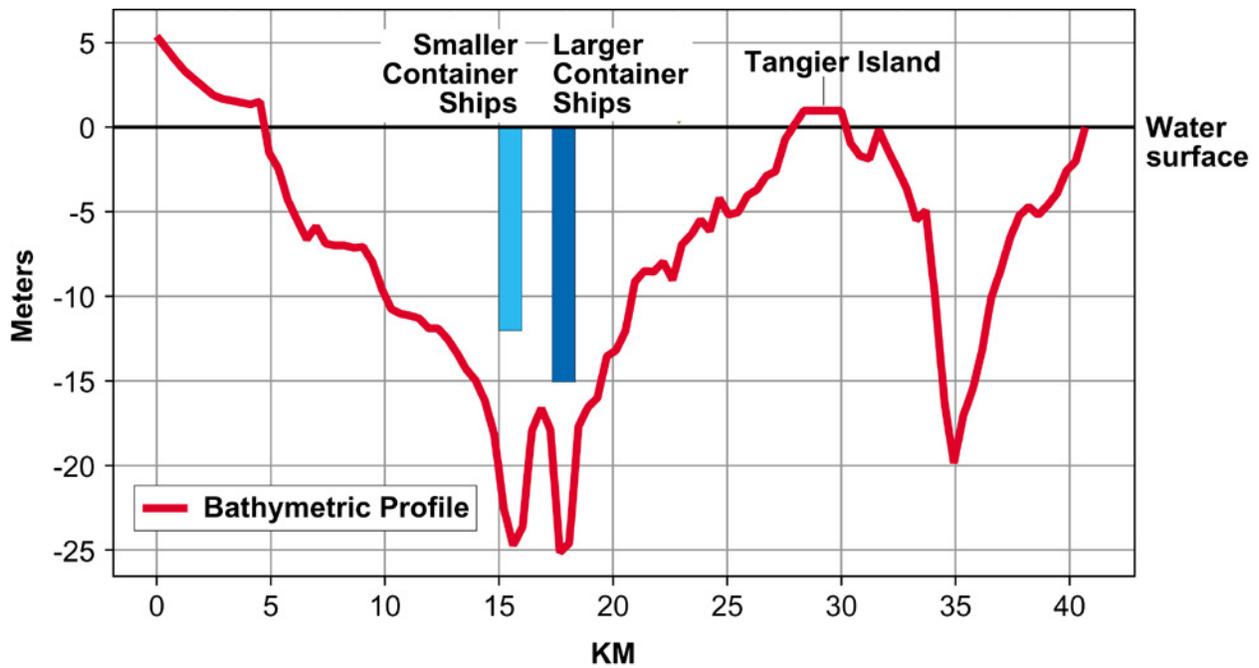
Figure 26. Cross-section of Chesapeake Bay through Tangier Island and depths of container ships.

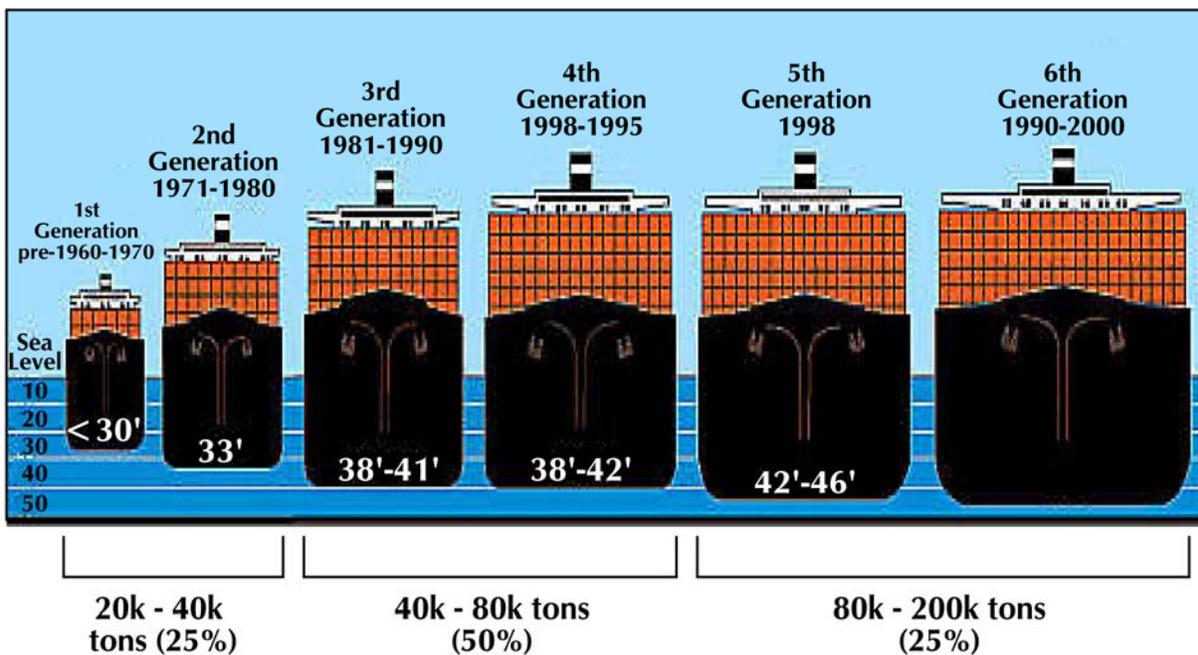
Figure 27. Evolution of container ships in Chesapeake Bay over past 50 years.

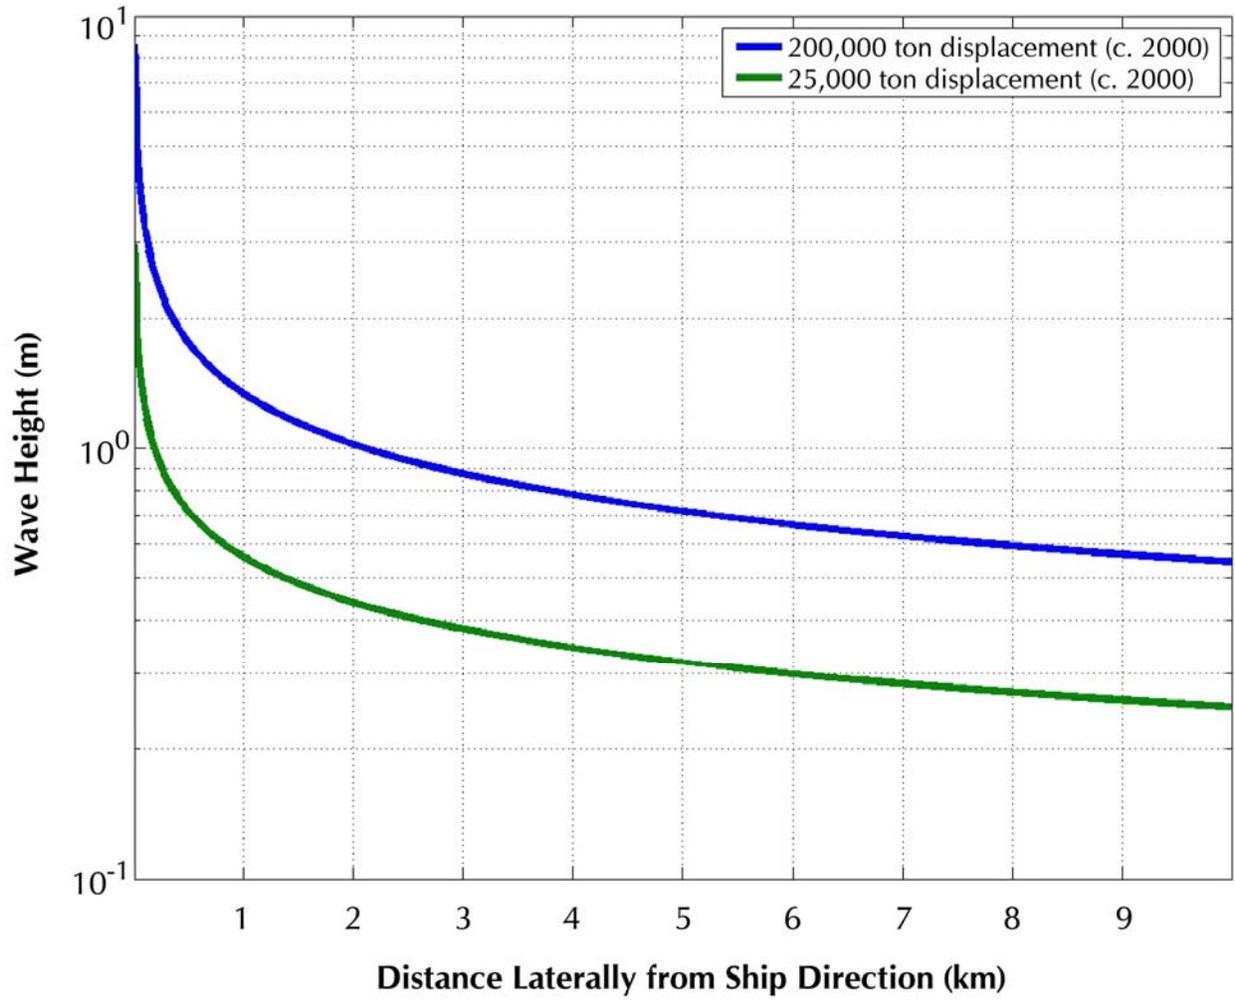
Figure 28. Predicted ship generated wave heights (depth Froude number = 0.8).

The approach to analyzing the effects of these waves on Tangier Island is based on a method of Weggel and Sorenson (1984). They developed dimensionless ship-parameter groups and fit observed wave data to quantify unknown coefficients. Figure 28 shows the predictions in terms of maximum wave heights versus lateral distance from the ship. Curves are shown for both 25,000 ton displacement vessels and 200,000 ton displacement vessels. For the smaller vessels, maximum wave heights drop off to less than 0.5 m in about 1 km, and to about 0.25 m in 10 km. However, for the larger vessels, wave heights greater than a meter persist for about 2 km, and are about 0.55 m at a distance of 10 km. Thus, the larger vessels are expected to produce significantly larger waves that potentially impact Tangier Island. However, due to the relatively small number of these vessels currently in the bay (less than 25 percent of the container ships fall in this range) and the predominance of larger wind-generated waves, it is not expected that the waves from these large vessels are significant with respect to shoreline erosion on Tangier Island.

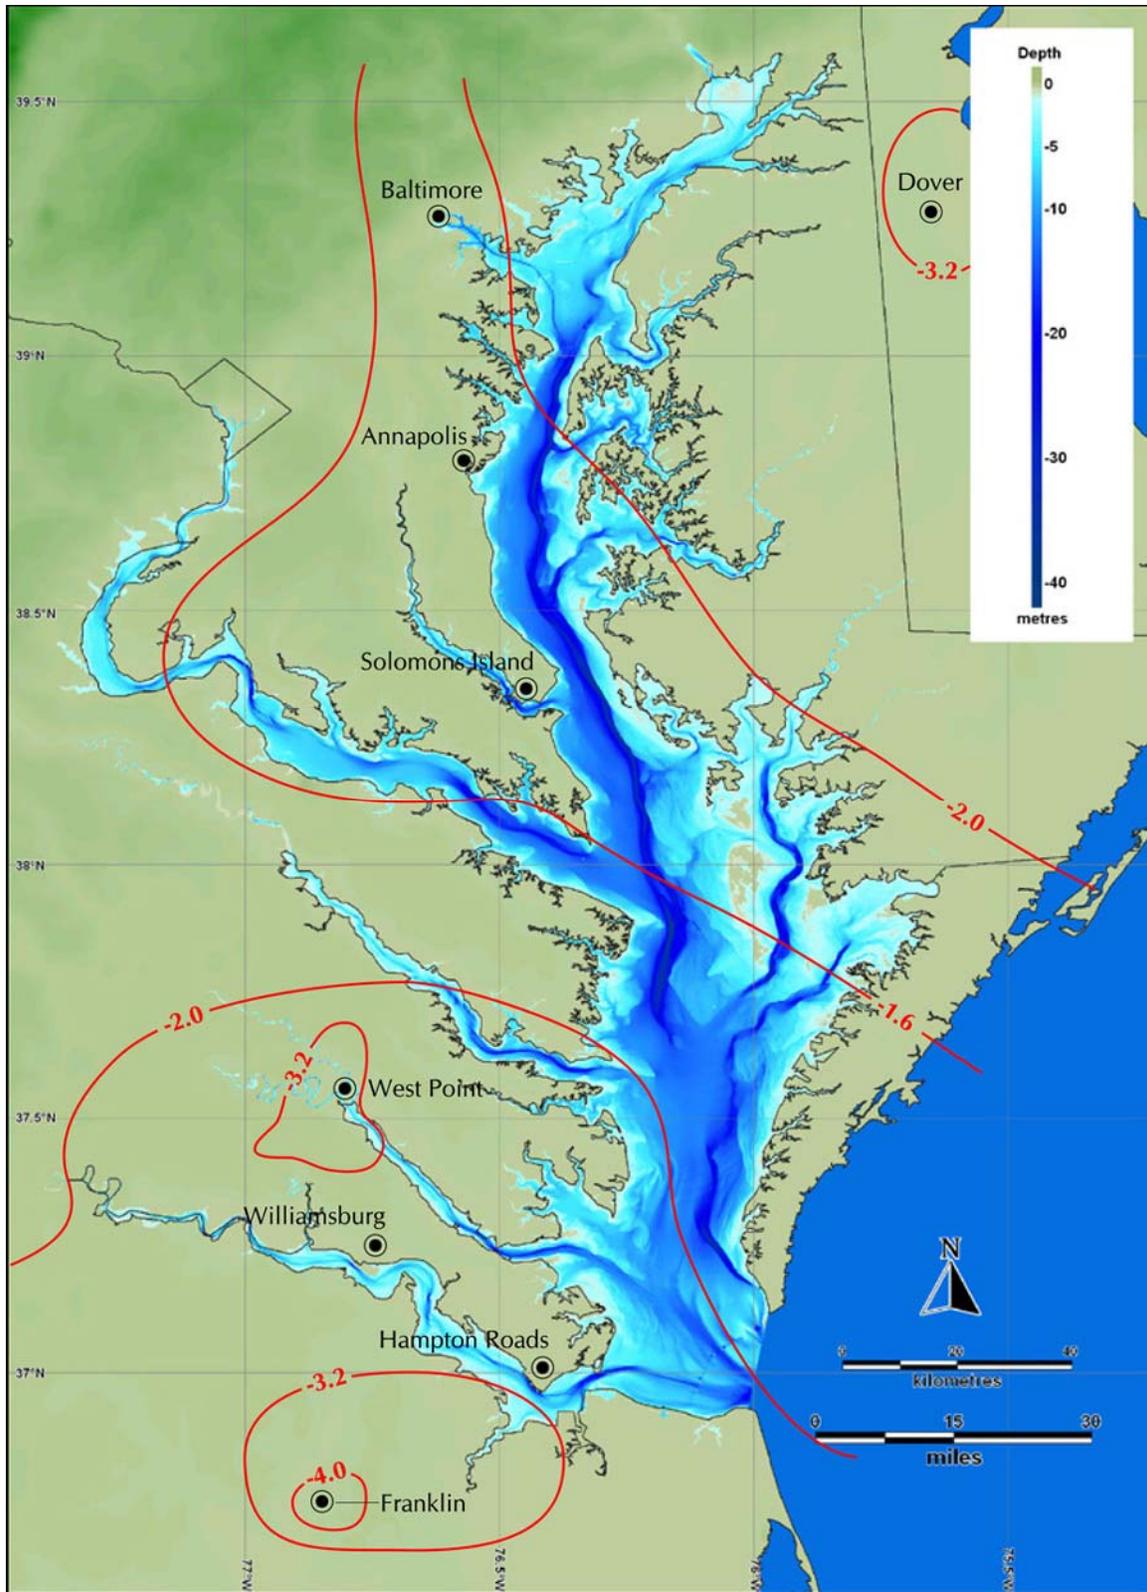
Figure 29. Estimated annual surface elevation changes (mm/yr) throughout Chesapeake Bay area (modified from Davis, 1987).

and Franklin. Figure 29 shows those areas of subsidence, along with subsidence in other areas of the Chesapeake Bay due to vertical coastal movements (in mm/yr). Note that away from the heavy pumping zones the vertical land subsidence (independent of pumping) is about -1.6 mm/year. However, near the larger pumping centers, additional subsidence is occurring such that total rates are between -3.2 mm/yr (West Point) and -4.0 mm/yr (Franklin). For the major locations of pumping, the following subsidence to head declines have been observed (Davis, 1987):

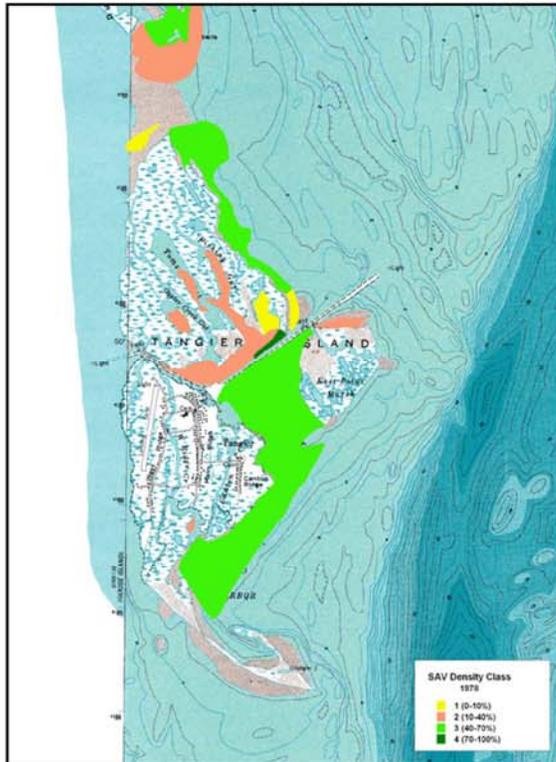
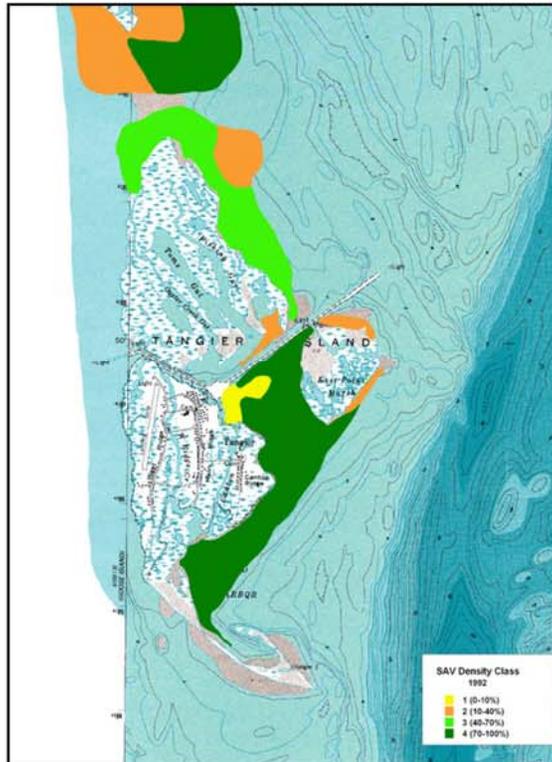
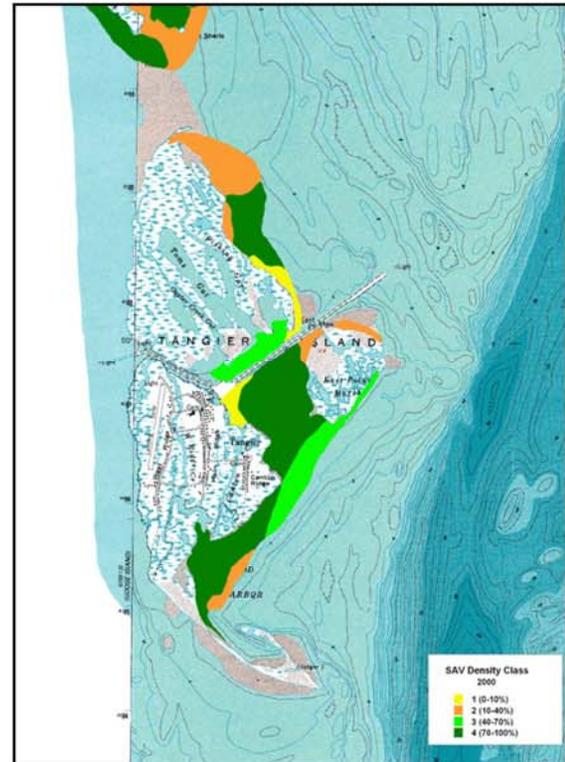
Figure 30. SAV densities around Tangier Island.

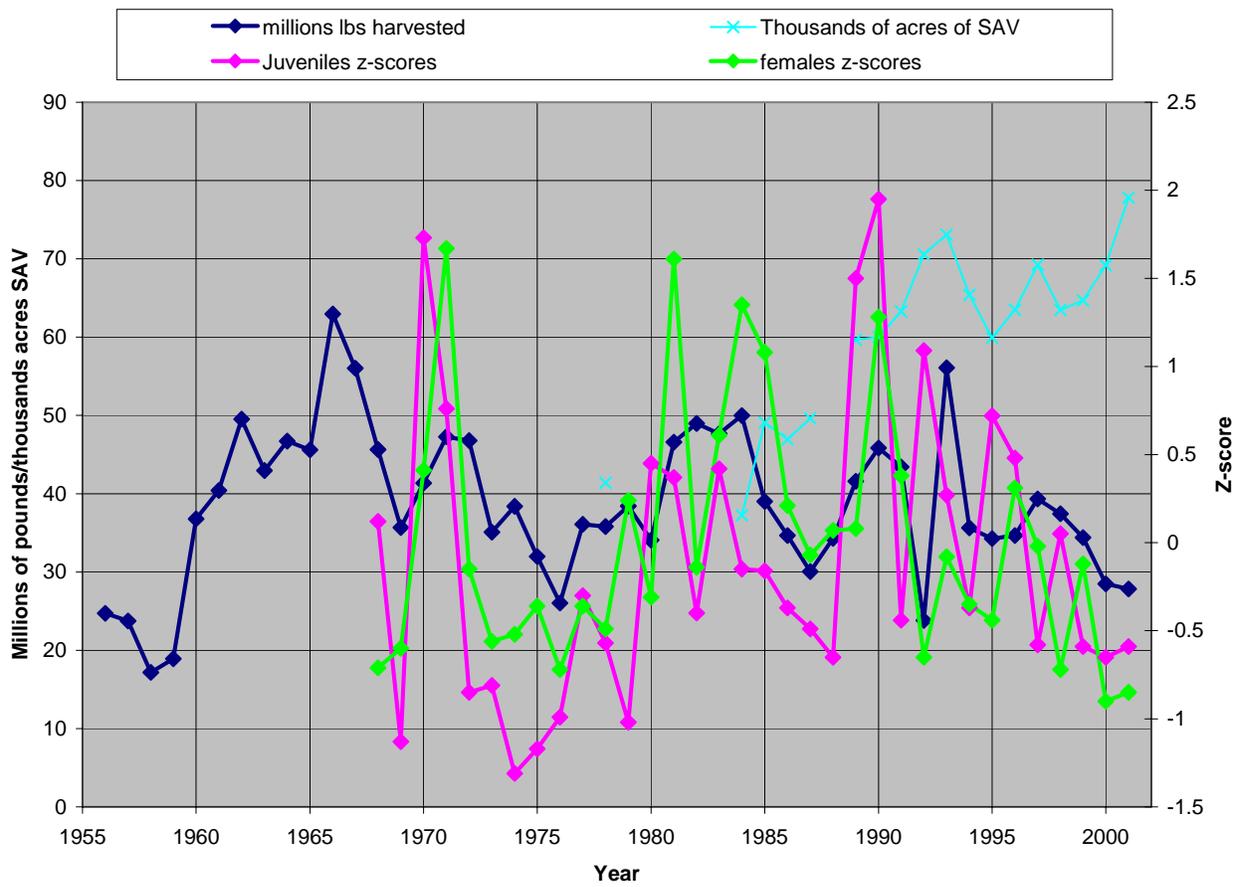
Figure 31. Indicators of Blue crab abundance in Chesapeake Bay and number of acres of bay covered with SAV.

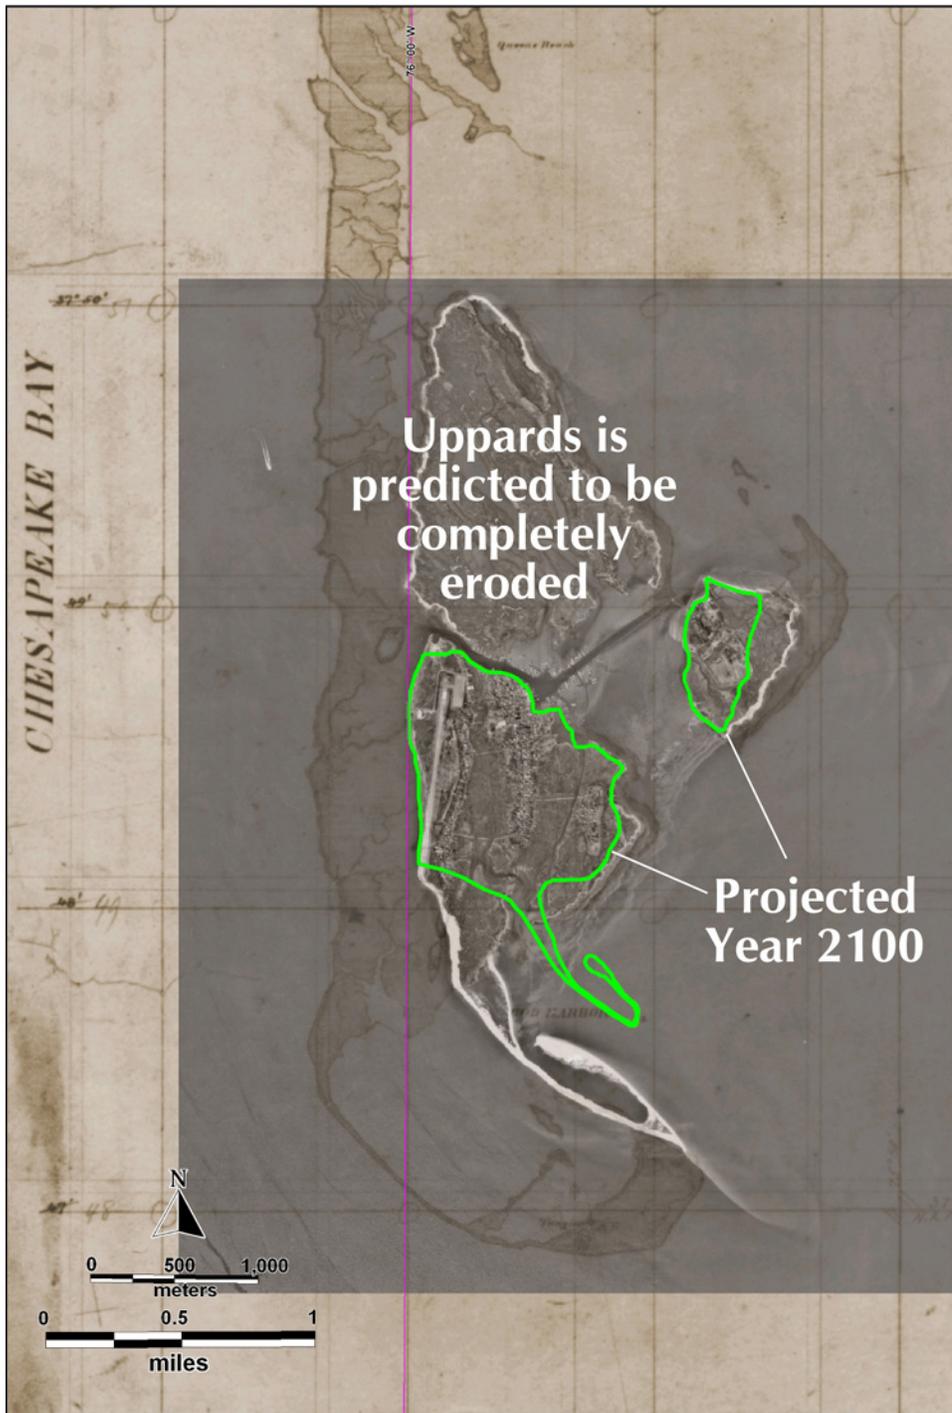
Figure 32. Comparison of Tangier Island: 1850, 2000, and projected to year 2100.
