# PREDICTIONS OF RELATIVE SEA LEVEL CHANGE AND SHORELINE EROSION OVER THE 21<sup>ST</sup> CENTURY ON TANGIER ISLAND, VIRGINIA

## ABSTRACT

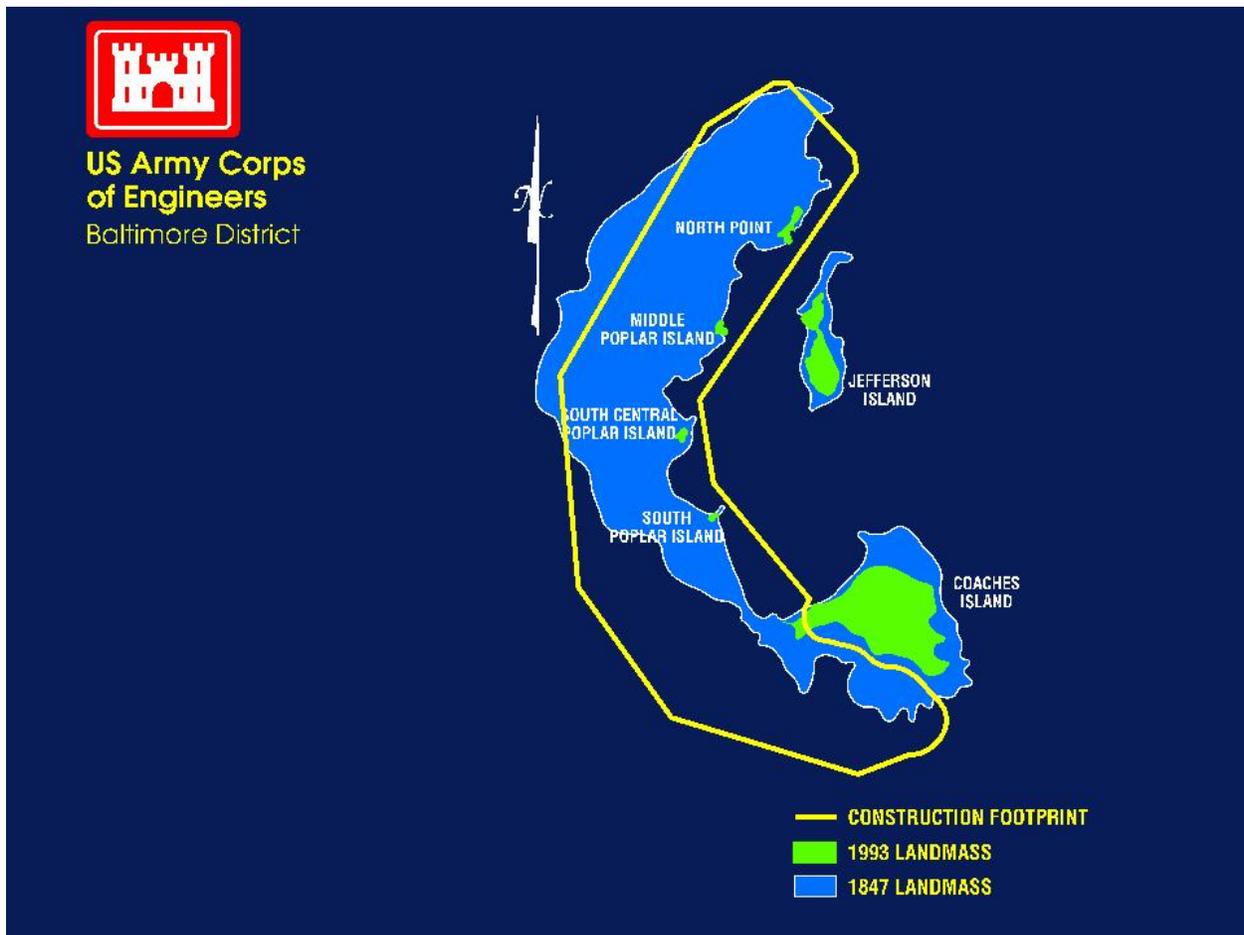
Figure 33. Outline of extent of proposed Poplar Island remediation  
(url: <http://www.nab.usace.army.mil/projects/Maryland/poplarisland.htm>)

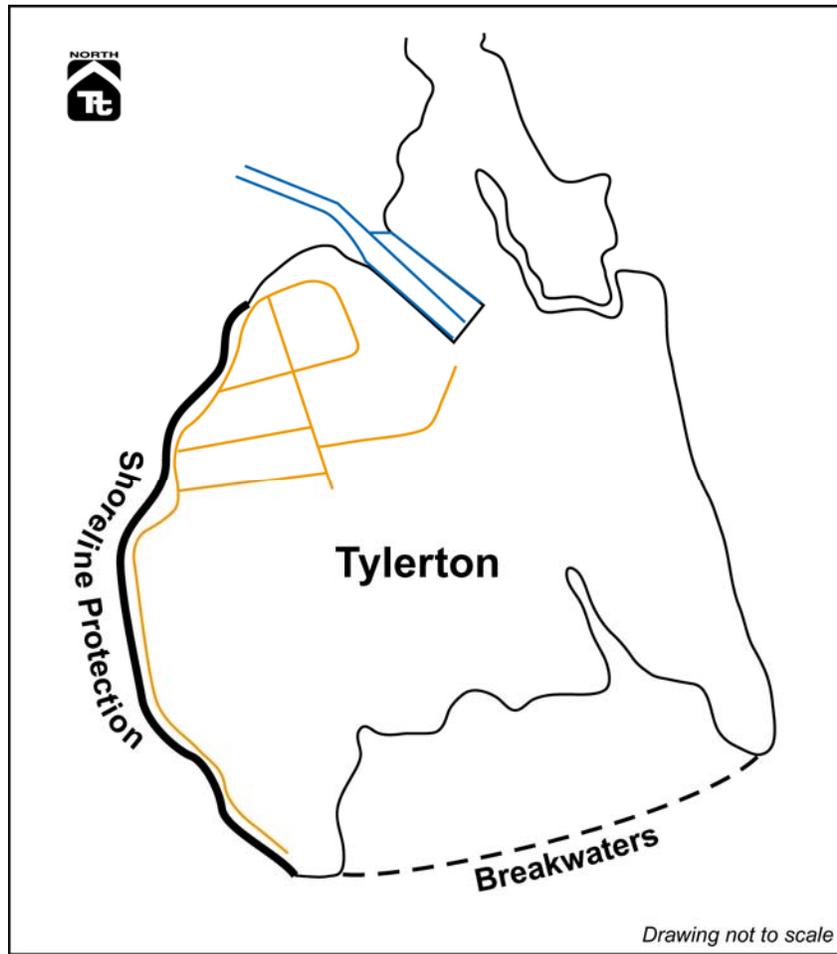
Figure 34. Shoreline erosion protection projects completed in Tylerton, Smith Island in 2001 (USACE, 2001).

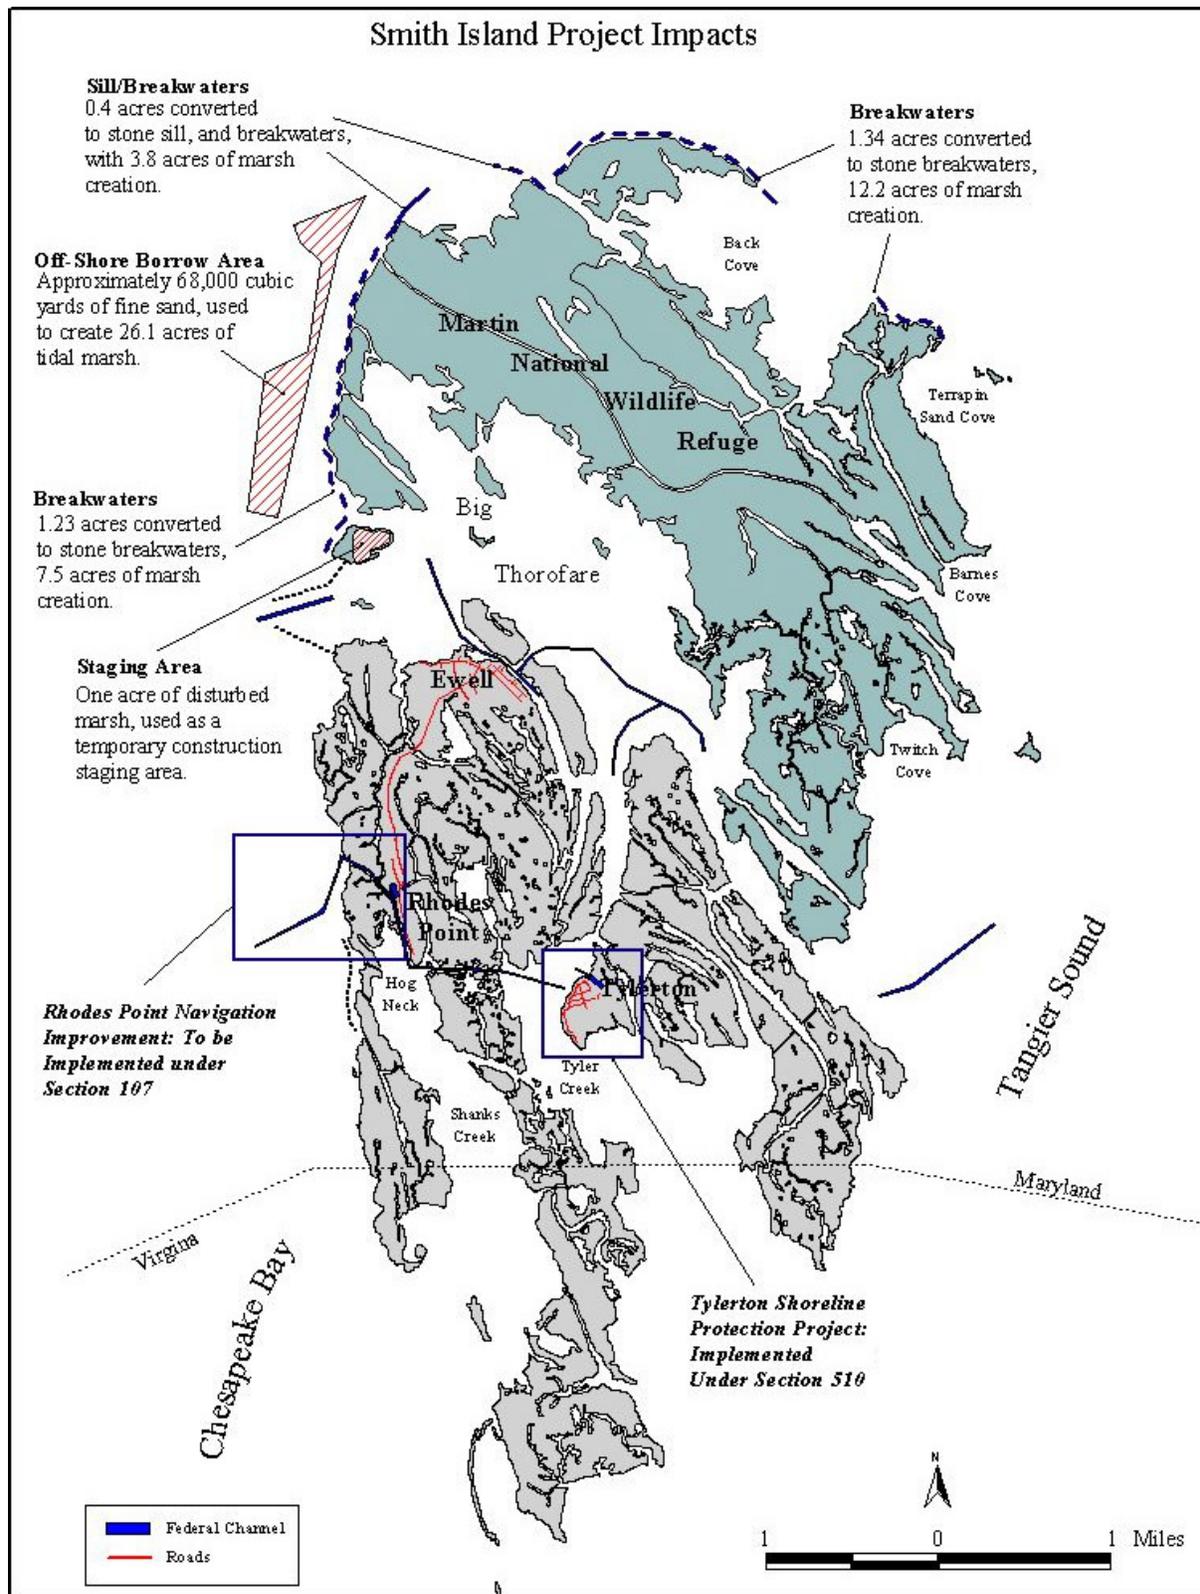
Figure 35. Proposed and recently completed remedial actions on Smith Island (USACE, 2001).

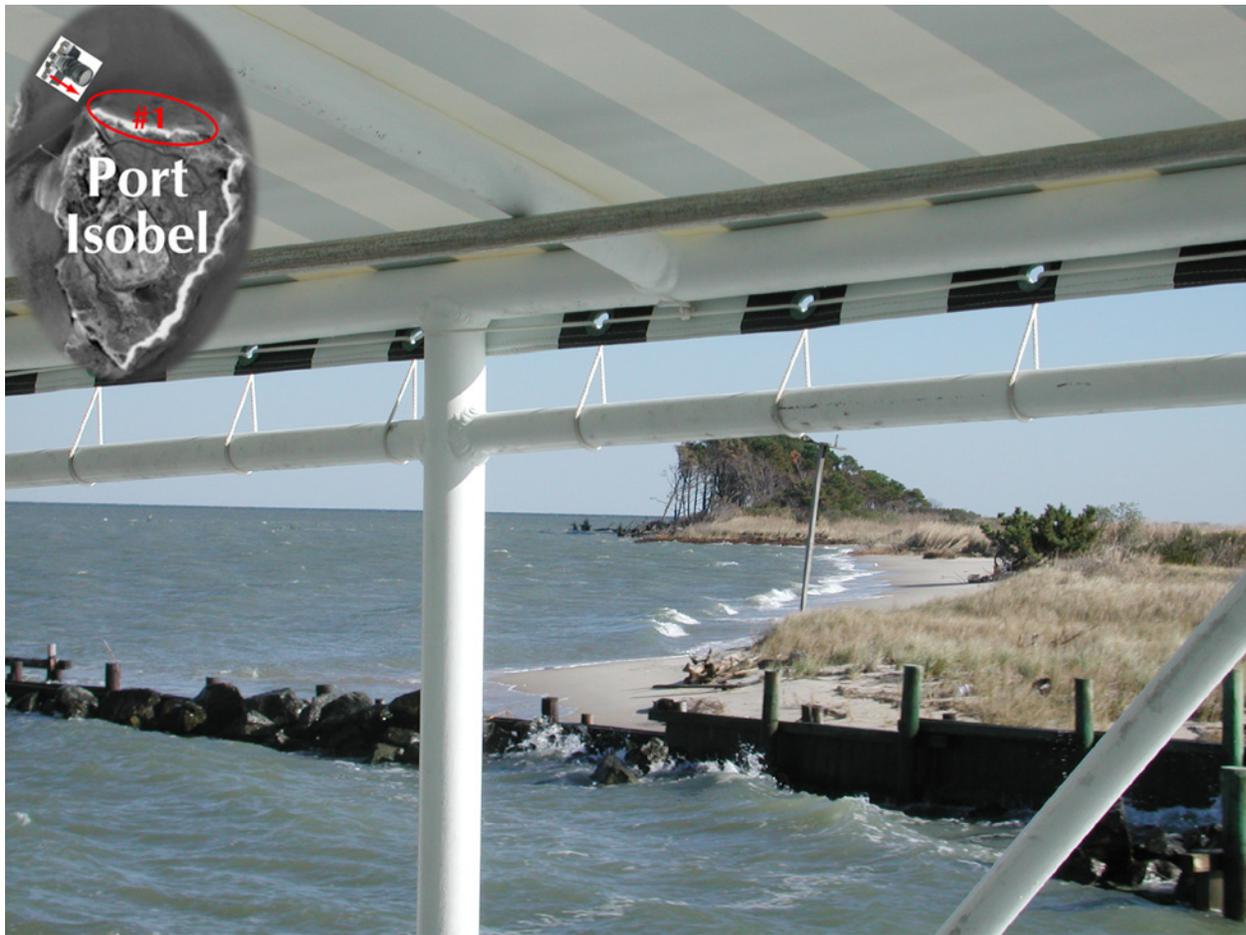
**Photograph #1 (November 18, 2002):** Erosion on Port Isobel. Shoreline erosion is more advanced at locations where pines trees, planted in the 1970's, are not present. This shoreline of Port Isobel is typically on the leeward side of the island, so the rate of shoreline erosion is less than on the western side of the island. On this day, winds were blowing from the northwest, and sizeable waves were impacting even the leeward side of the island.

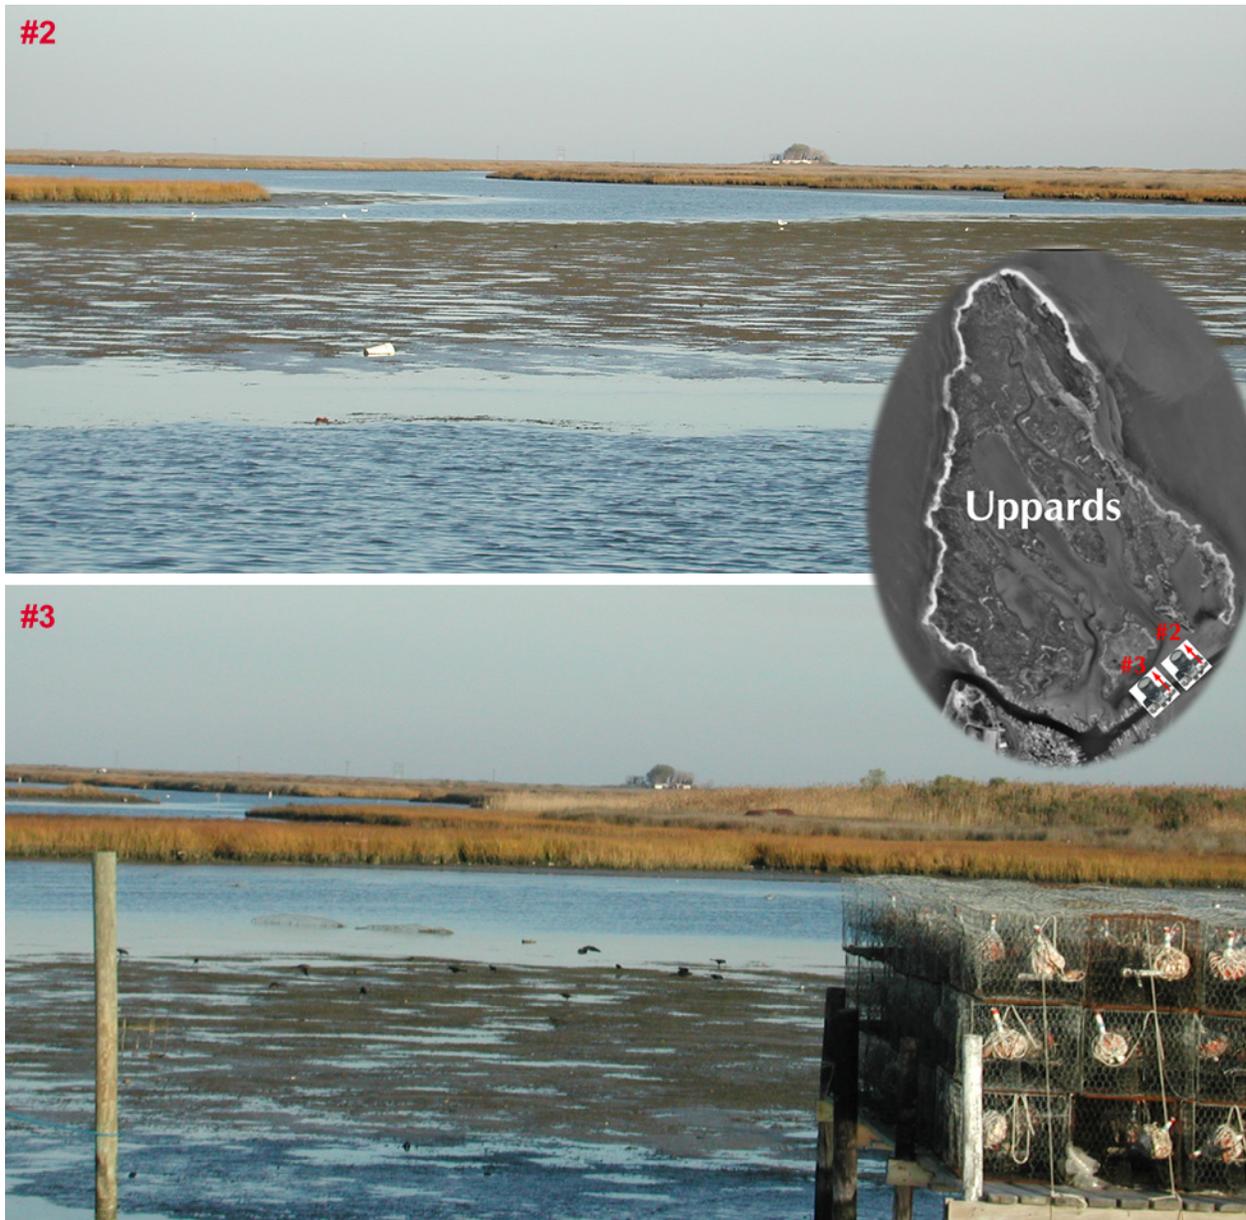
**Photographs #2 and #3 (November 19, 2002):** Looking towards Uppards at a time of extreme low tide. Sea grass is evident on the exposed tidal flats. A hunting lodge is present in the extreme far distance. The channels on the far side of the mud flats run nearly the entire distance of Uppards, and are called "guts". Within a few years at least one of these guts (Tom's Gut) may be connected directly to the bay, assuming erosion continues at the present rate.

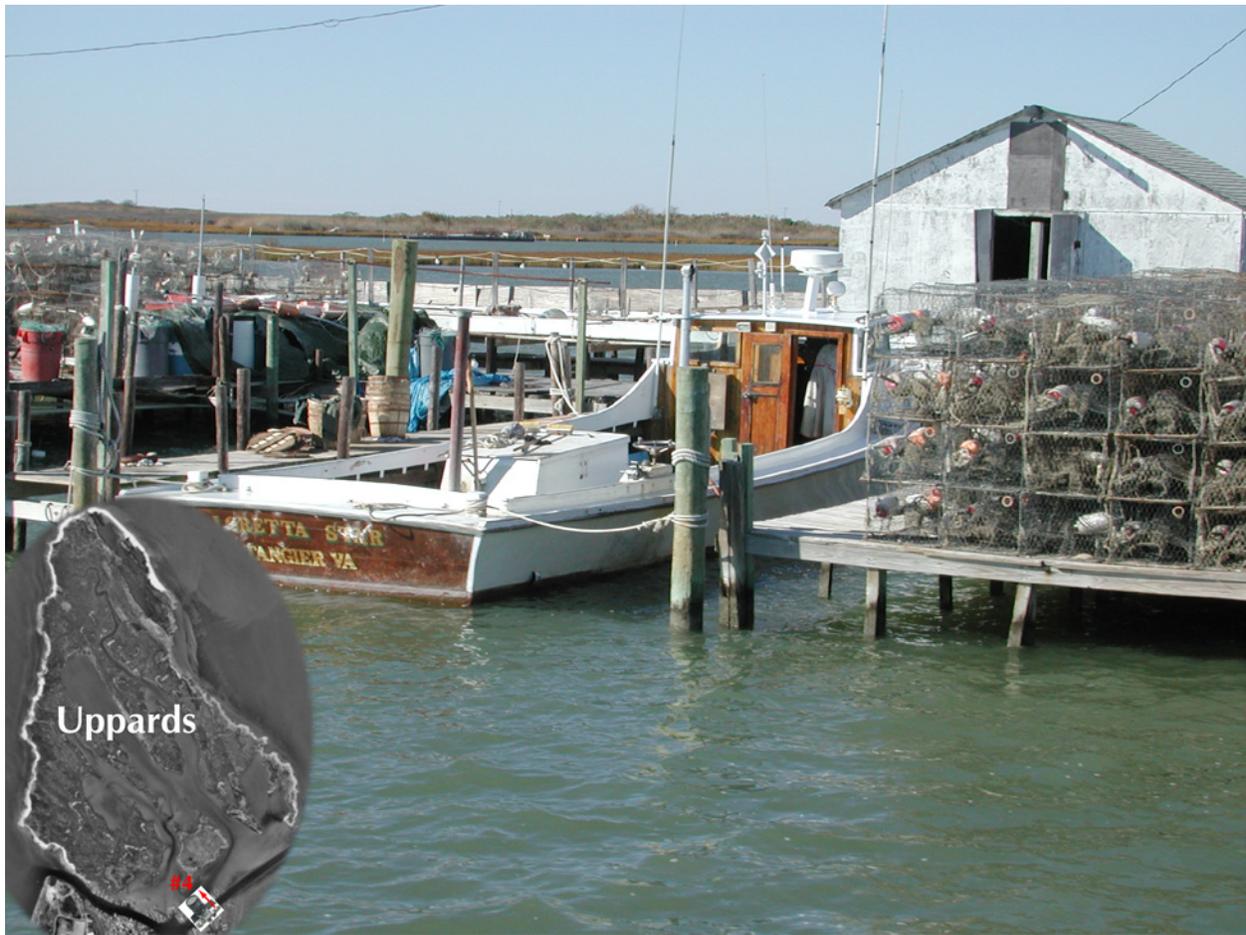
**Photograph #4 (November 18, 2002):** The Loretta Star in dock on the north side of the main channel and harbor that runs approximately east west through the island. The crab pots have been put in storage for the winter. Uppards can be seen on the far side.

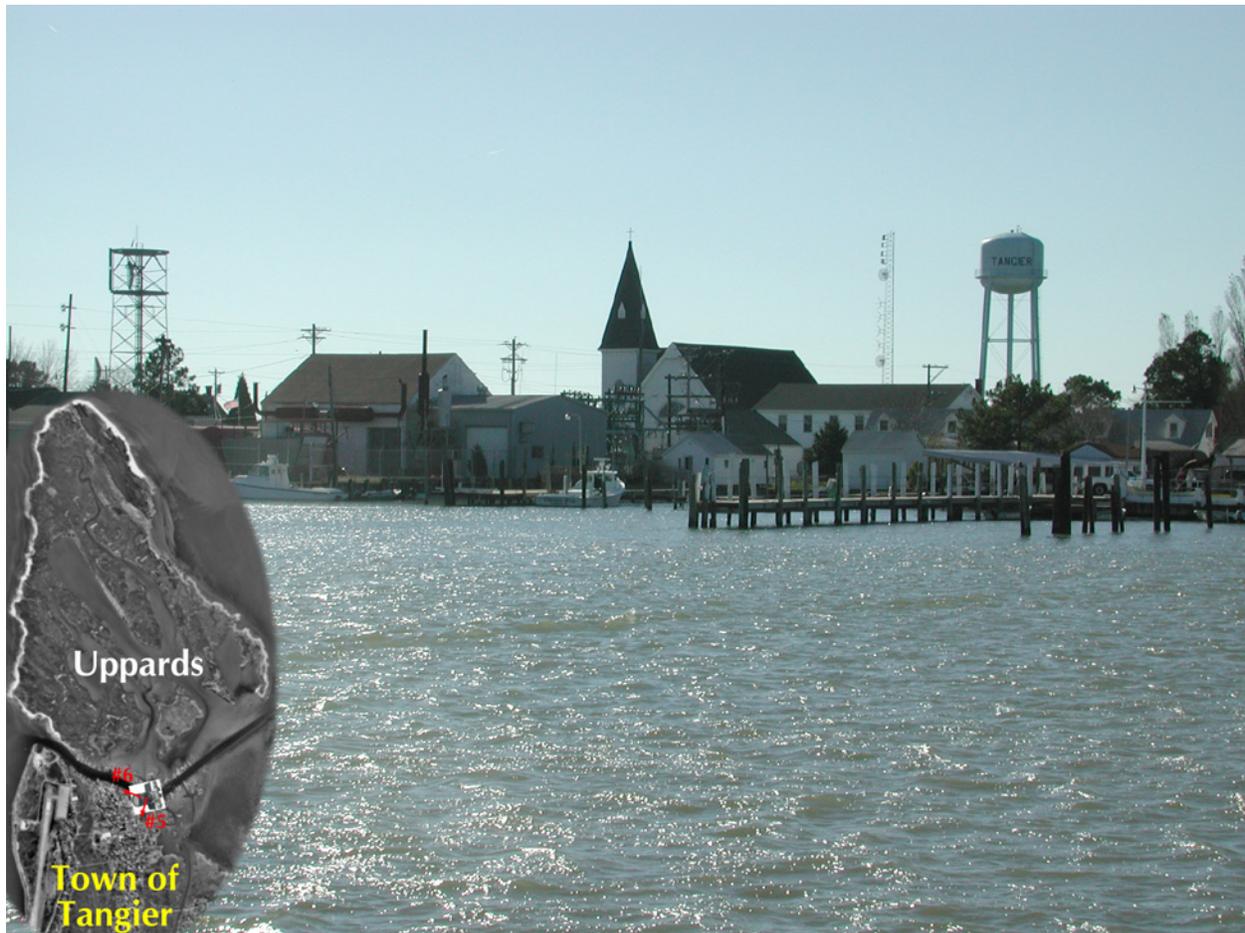
**Photograph #5 (November 18, 2002):** In the main harbor area looking to the southeast. The Swain Memorial Church can be seen in the background. The large building in the left foreground is the power plant that supplies electricity to both Tangier Island and Smith Island to the north.

such conditions the harbor would no longer be able to function as a safe haven. The town of Tangier Island, which borders the harbor, would then be exposed to the severe wave forces generated within the bay. Photographs 5 and 6 in the Exhibit illustrate how the town is built next to the channel, and structures exist on both sides of the channel.

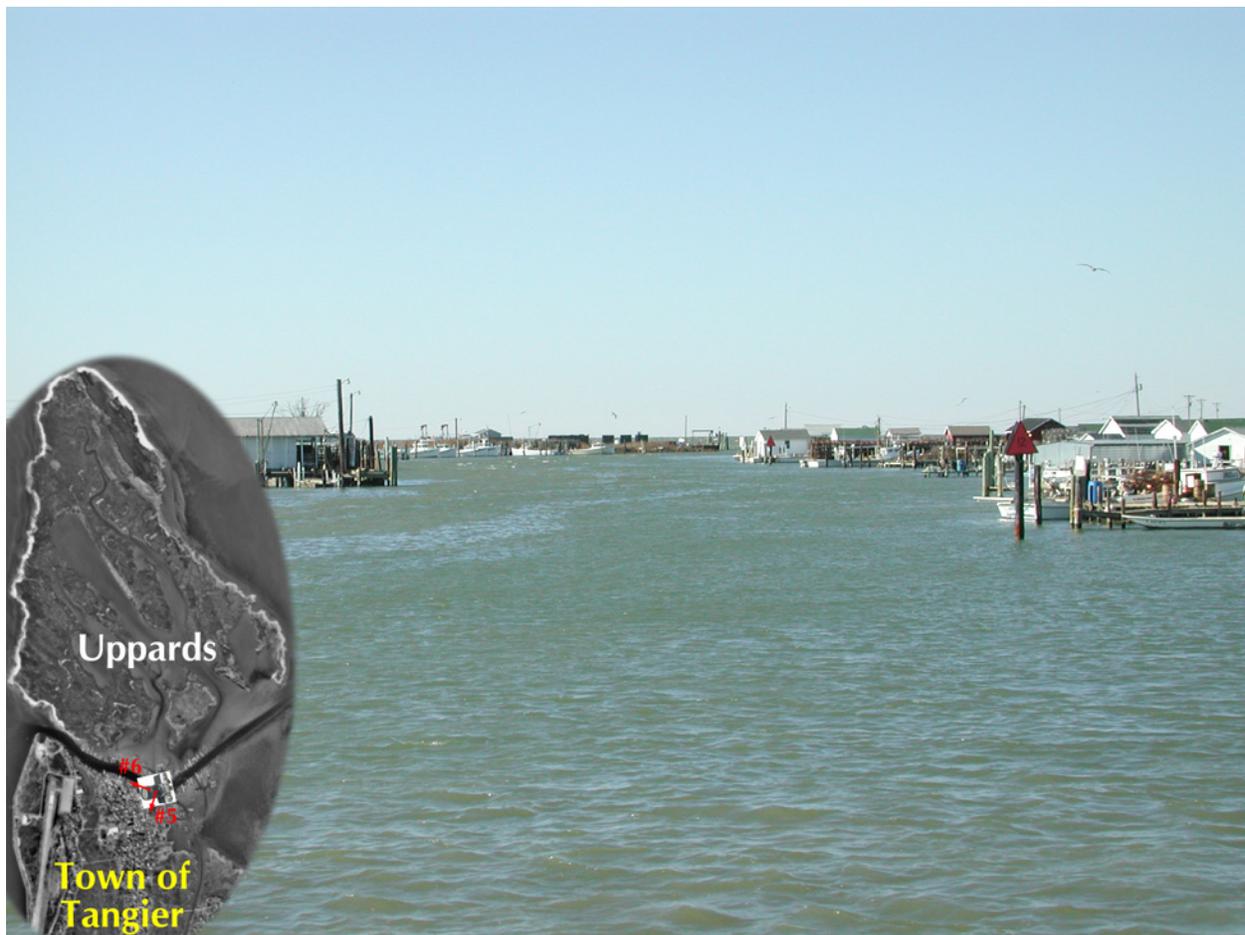
**Photograph #6 (November 18, 2002):** In the main channel looking all the way to the open bay to the west. Note the heavy development all along the channel on both sides. Typically on the right (adjacent to Uppards) crab houses are located. On this day a strong northwest wind was blowing and white caps can faintly be seen entering the harbor.

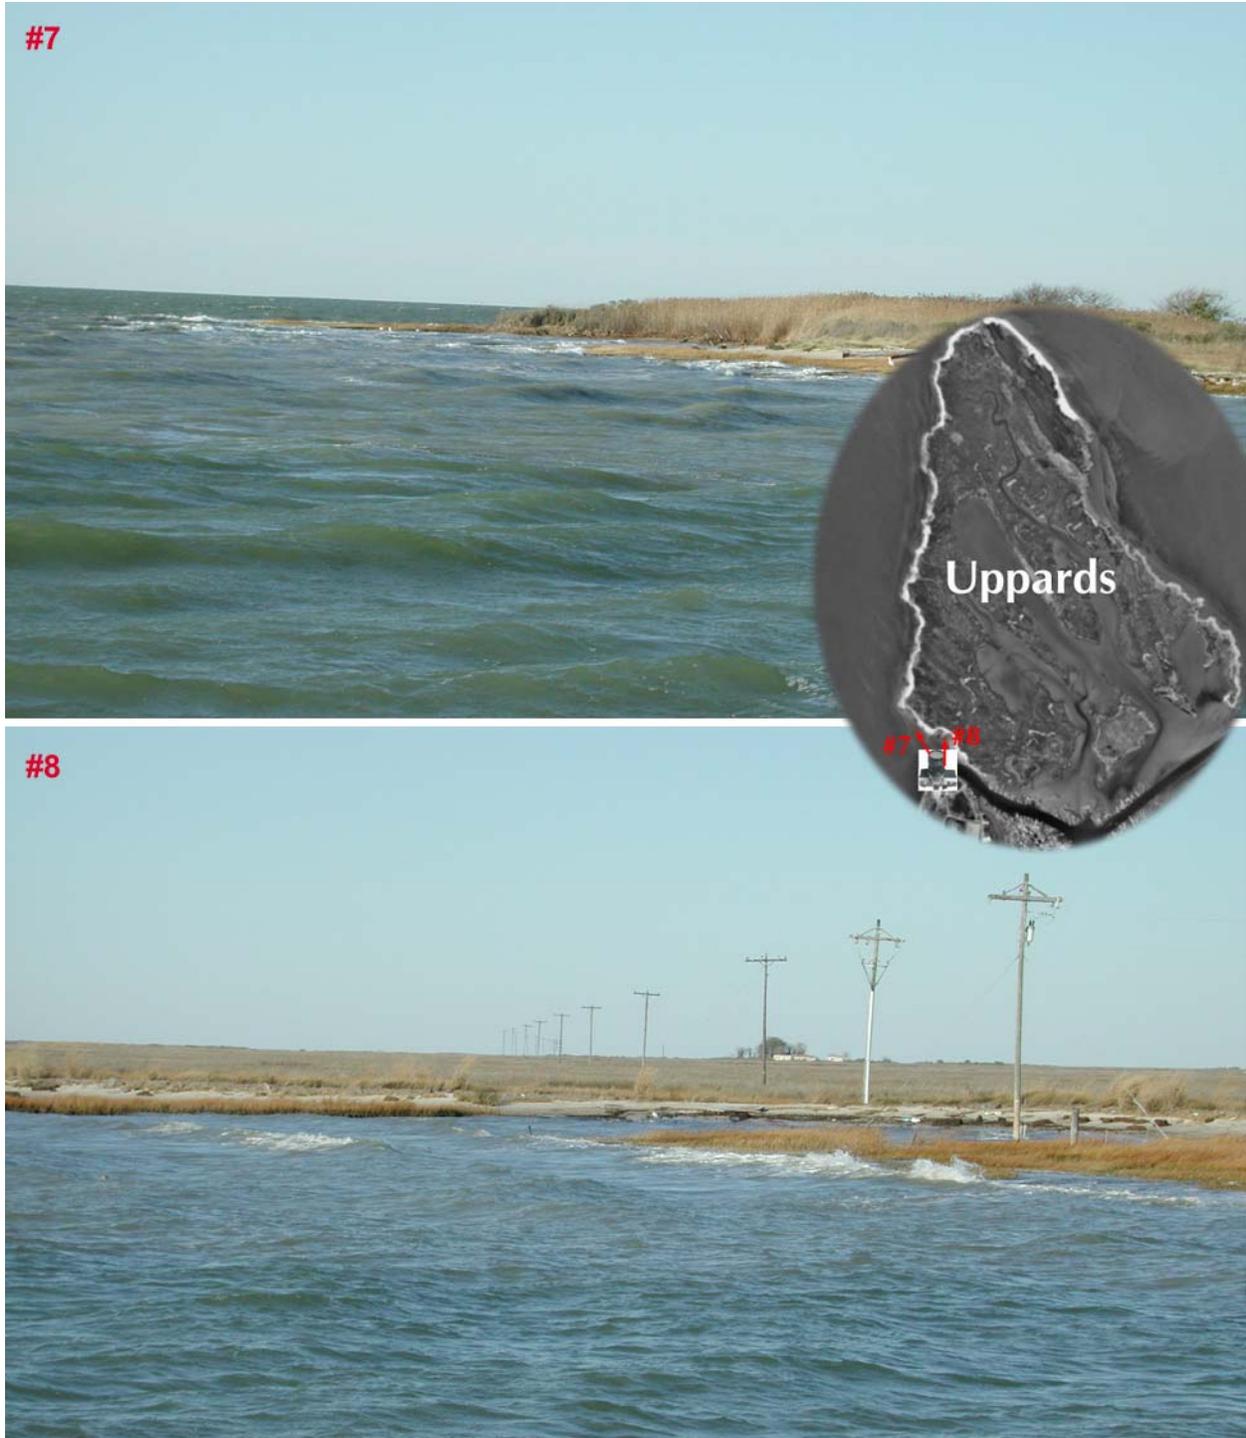
**Photograph #7 and #8 (November 18, 2002):** At the western entrance to the Tangier North Channel. A strong northwesterly wind was blowing large waves into the harbor. Evidence of shoreline erosion on the shoreline across the channel is evident. The power lines transmit electricity to Smith Island to the north.

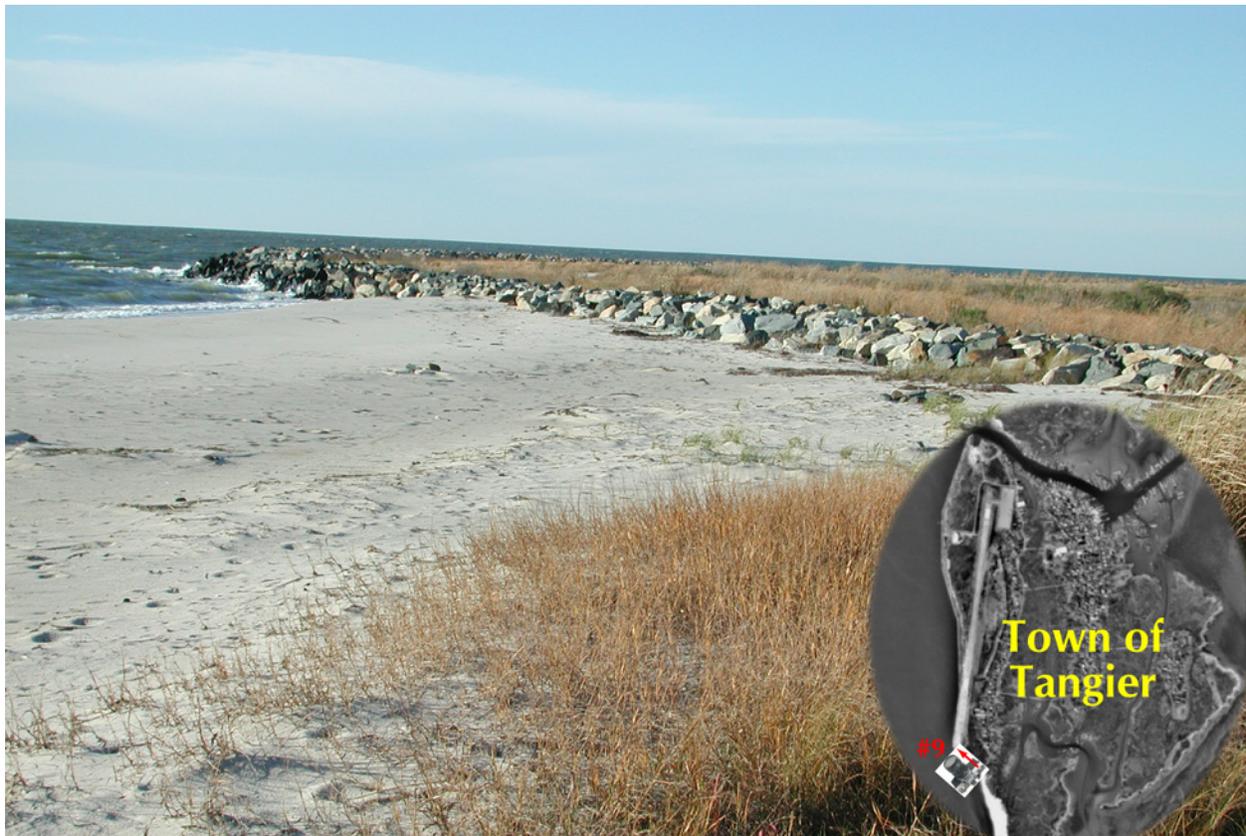
**Photograph #9 (November 18, 2002):** At the southern end of the seawall that was constructed in 1990. The erosion that occurred from 1990 to 2002 is evident by comparing the marsh grass retreat on the protected and unprotected sides of the seawall.

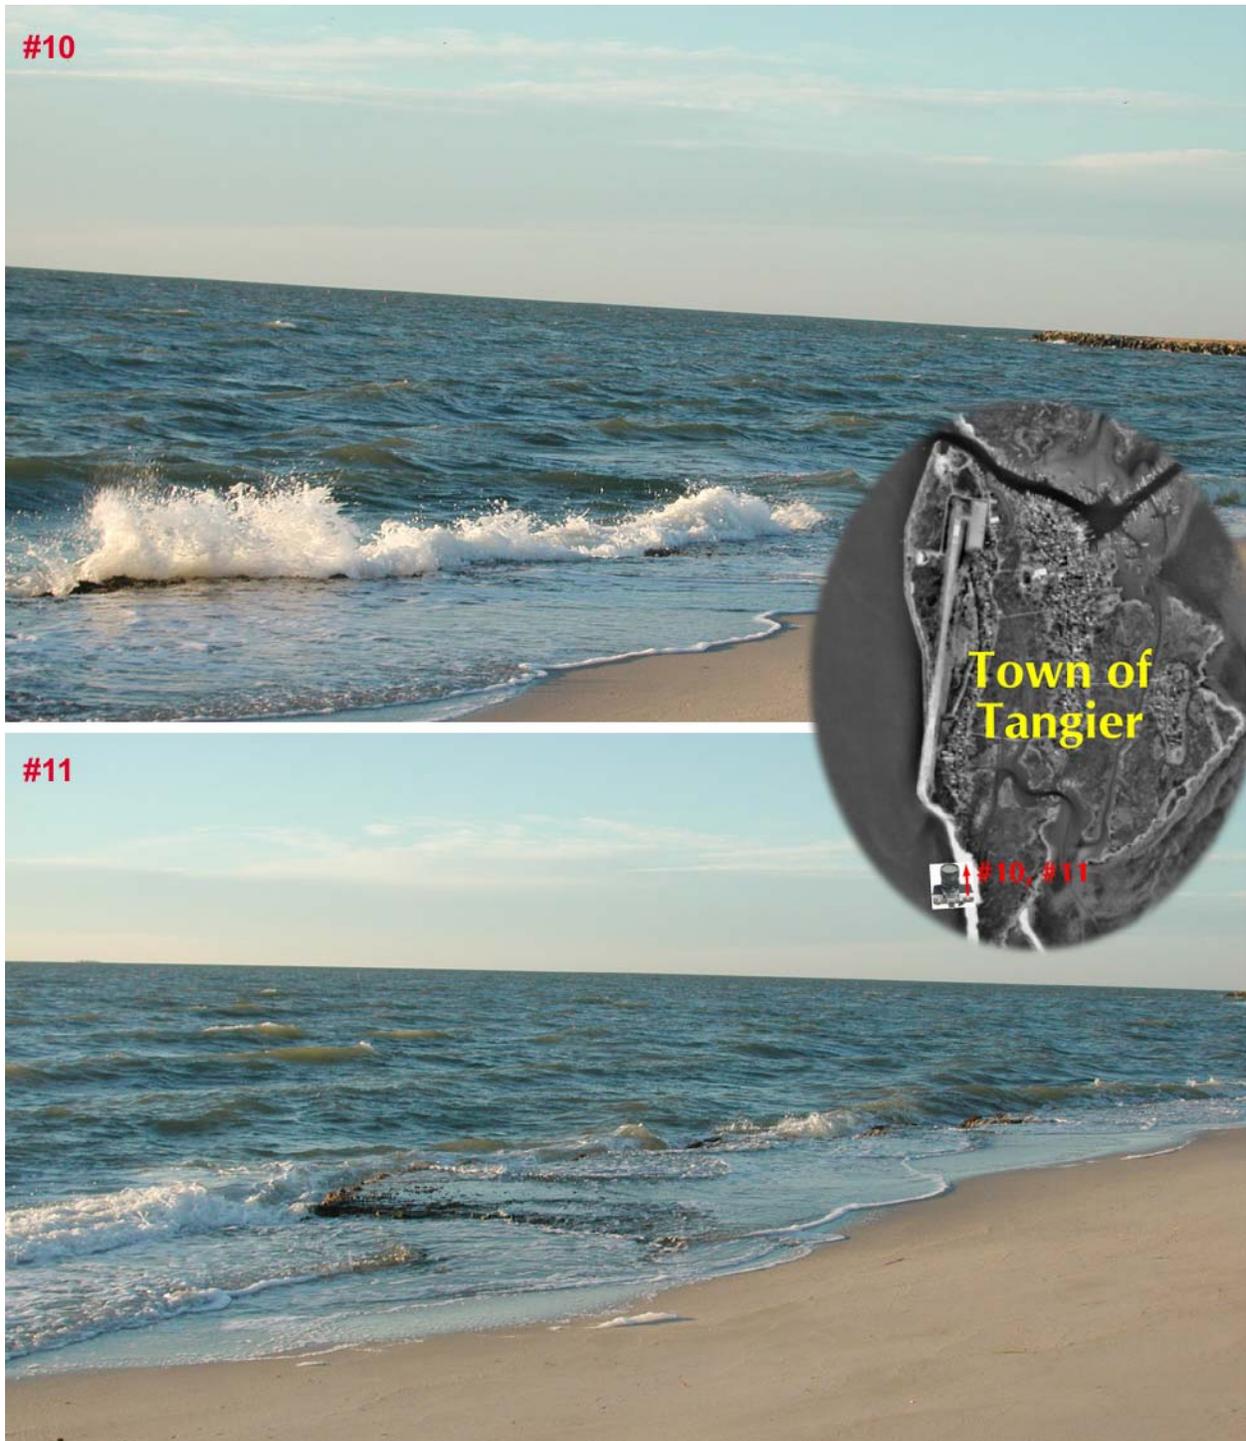
**Photographs #10 and #11 (November 18, 2002):** At the shoreline (low tide conditions) deposits of peak can be seen and cause the waves to splash upon impacting the deposits. This is evidence of a past lower sea level, and illustrates that the shoreline is both eroding and migrating to the east in this area.

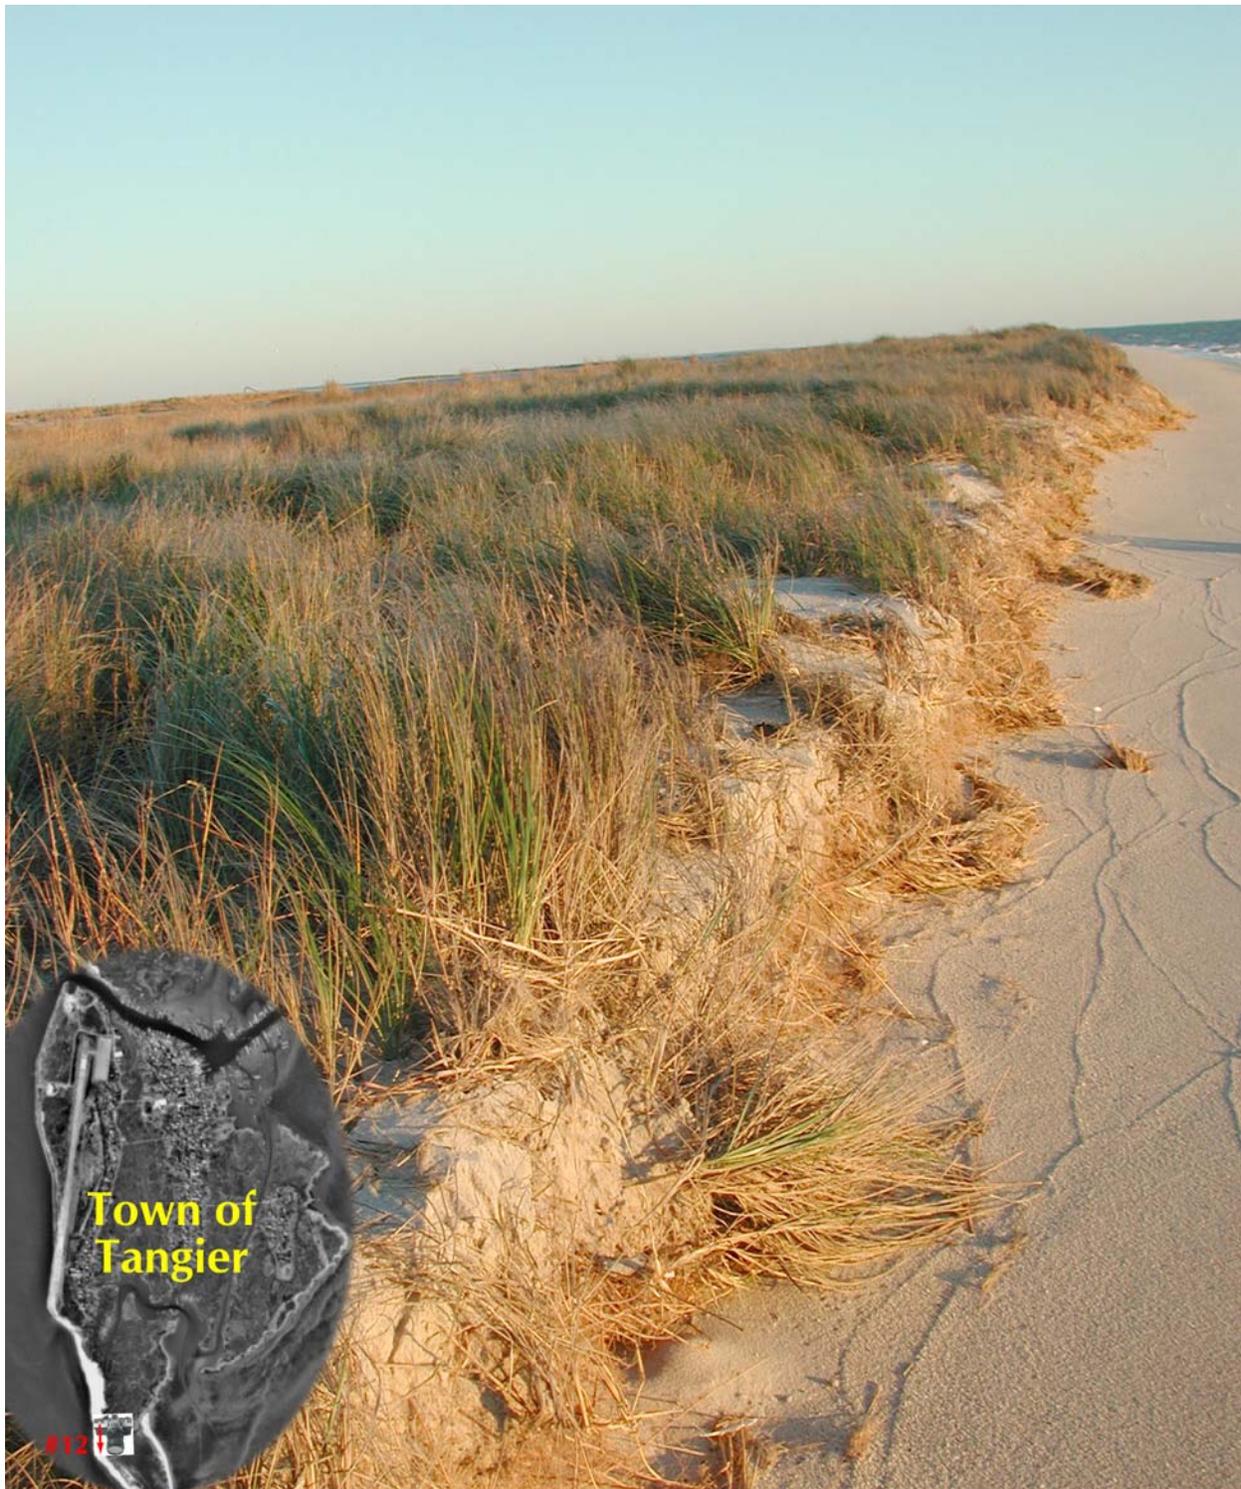
**Photograph #12 (November 18, 2002):** Active erosion of the marsh grass that anchors the sand dune. Near the end of November active photosynthesis has ceased in most of the grasses, and they have turned brown. As seen in the photograph, a few exceptions are evident.

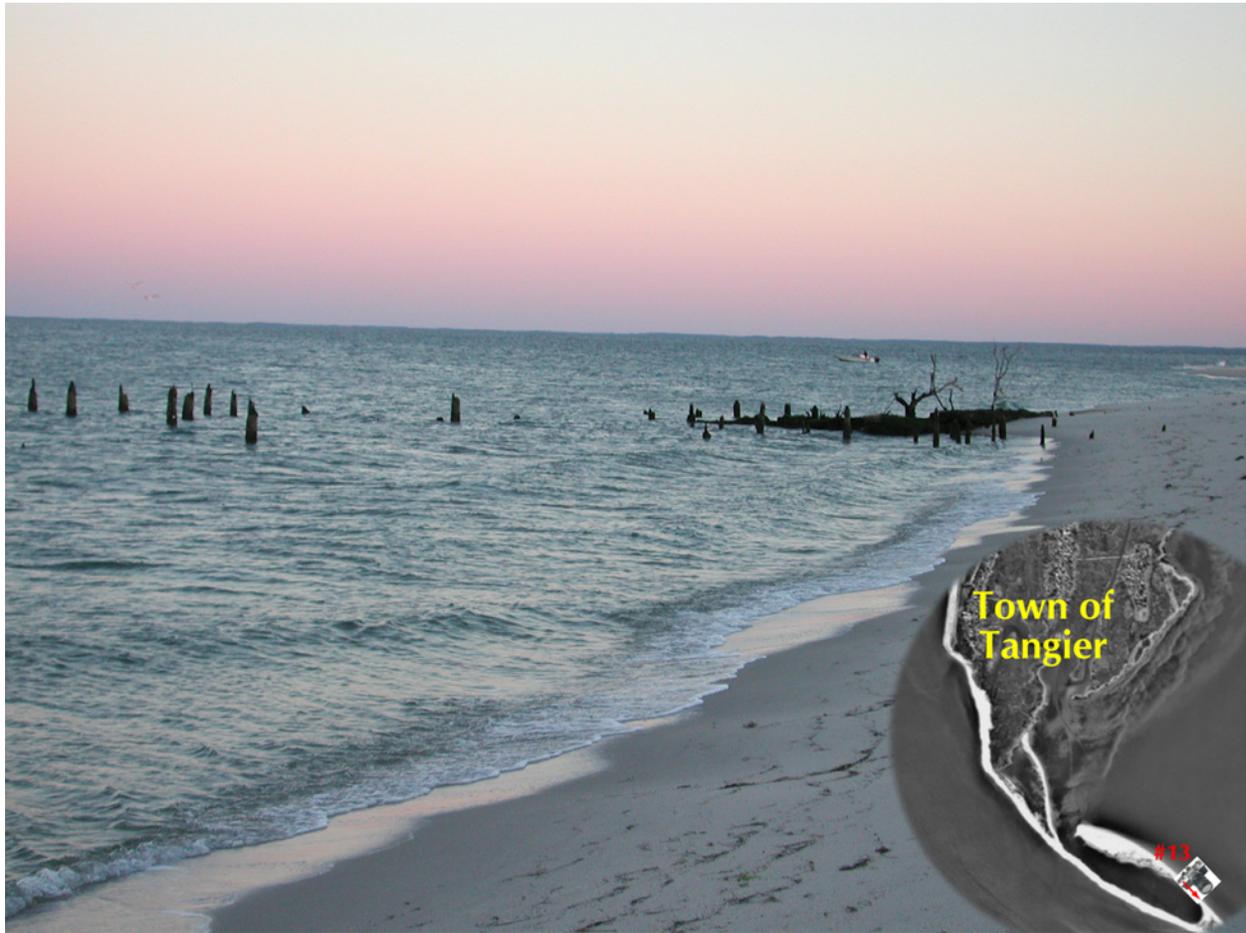
**Photograph #13 (November 18, 2002):** The remnants of an old pier. Note the pilings that are barely sticking out of the sand. This is evidence of the eastward migration of the sand over the years.

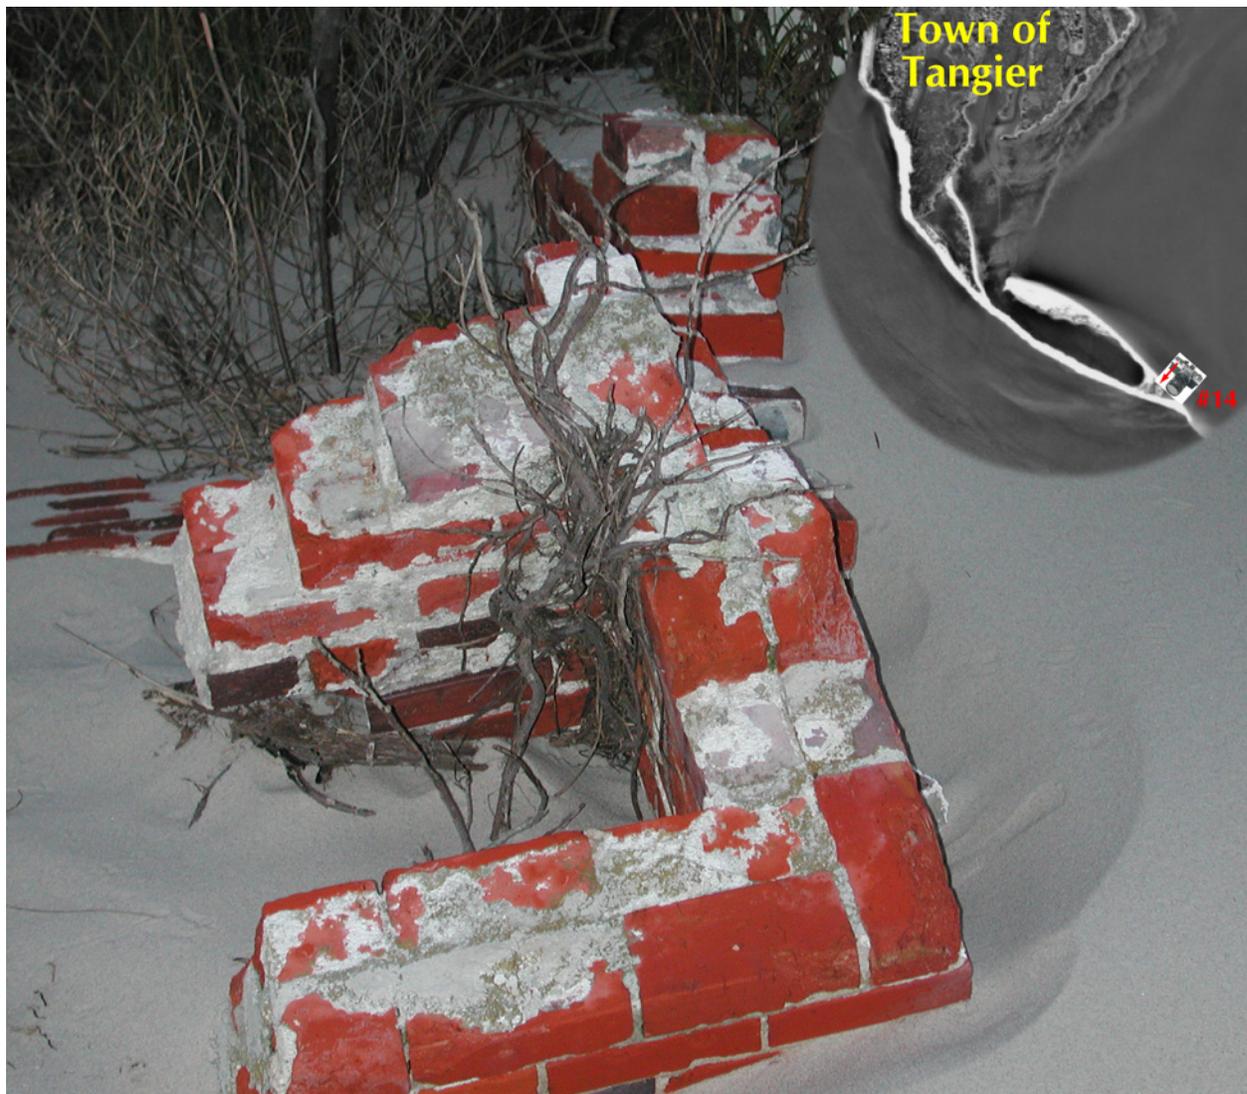
**Photograph #14 November 18, 2002):** A fallen brick structure partially buried by the migrating sands.

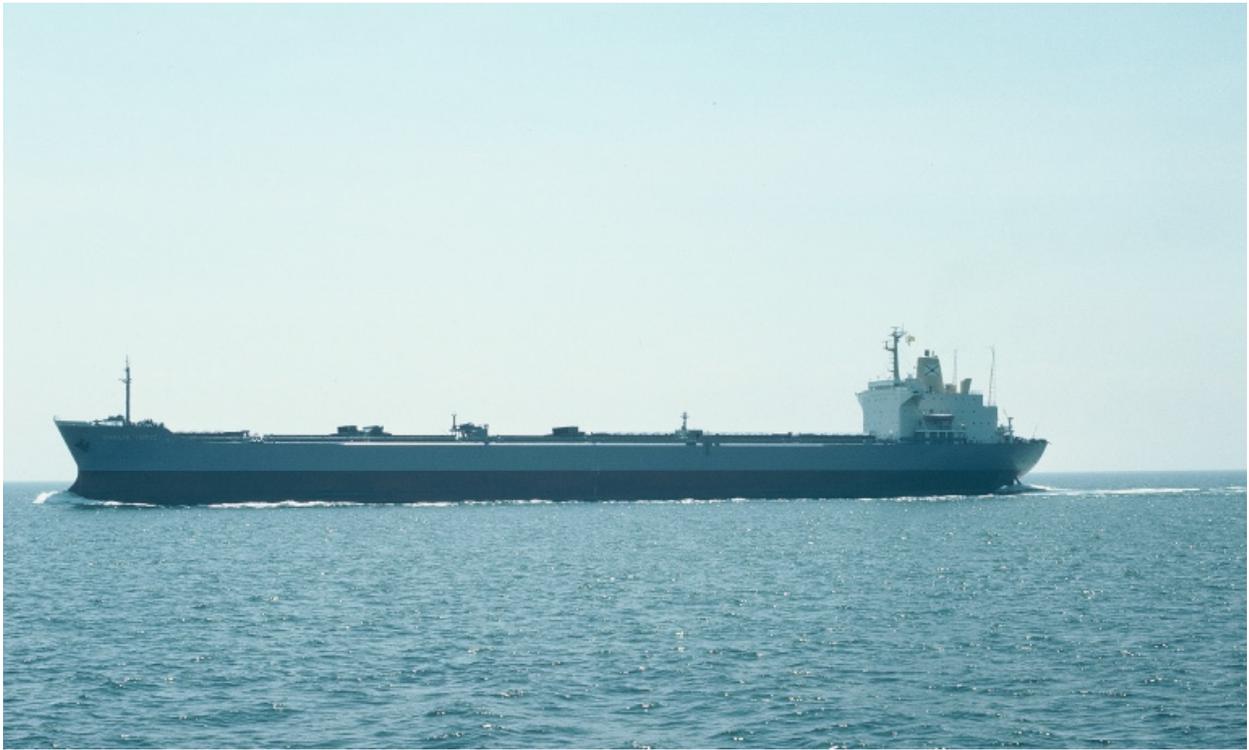
**Photograph #15 (June, c. 1978):** A large ship in the main channel of the Chesapeake Bay, about 10 km west of the island.

bay for nearly 50 years. Pre-1960 vessels displaced approximately 20,000 tons, while the largest vessels today displace more than 175,000 tons. In the Exhibit, photograph 15 shows an example of a large ship traveling in the ship channel just west of Tangier Island (c.1975).
